Lake & Watershed Management Plans for Lakes Rippowam, Oscaleta and Waccabuc

Town of Lewisboro, Westchester County, NY

Three Lakes Council Public Presentation – October 25, 2019

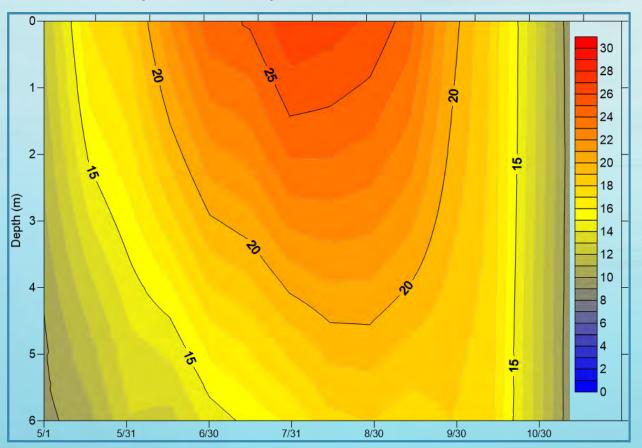
Lake Rippowam Dissolved Oxygen & Temperature

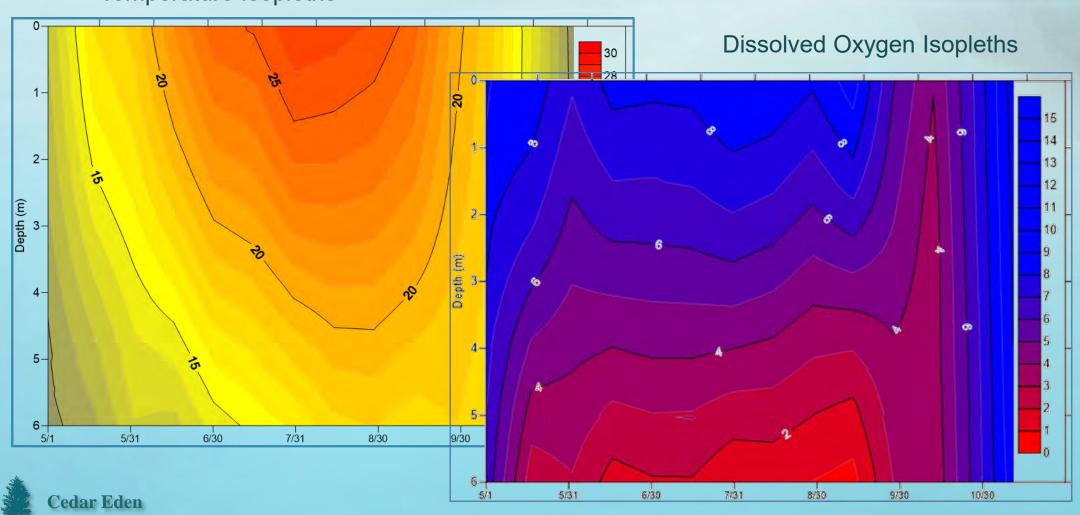
Lake Rippowam Dissolved Oxygen & Temperature

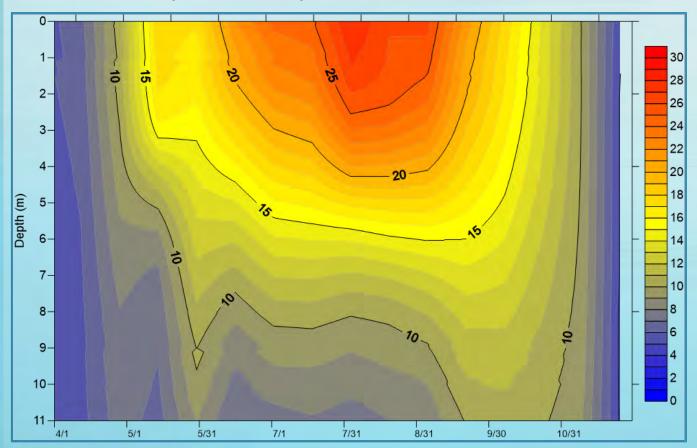
Lake Oscaleta Dissolved Oxygen & Temperature

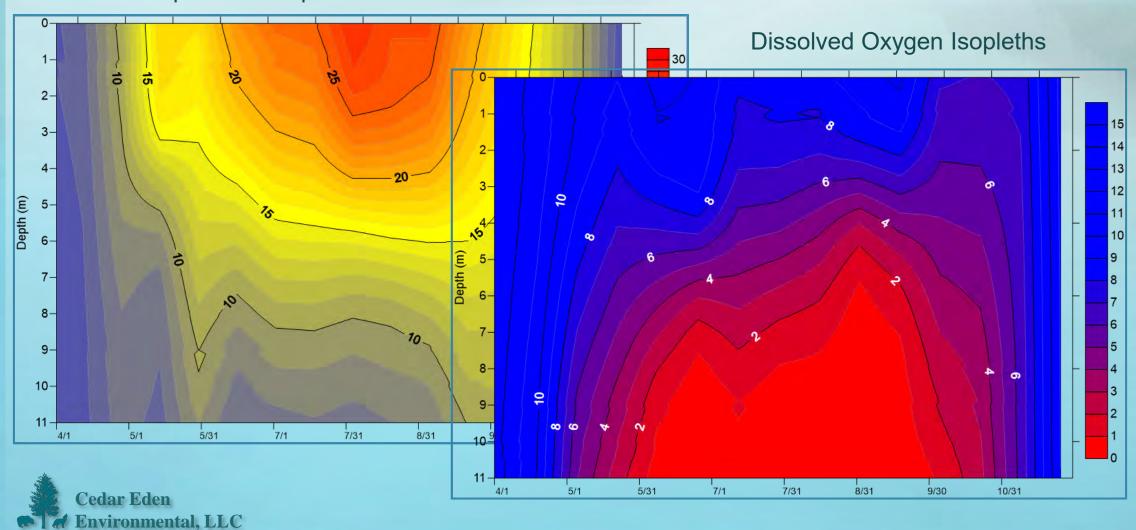
Lake Oscaleta Dissolved Oxygen & Temperature

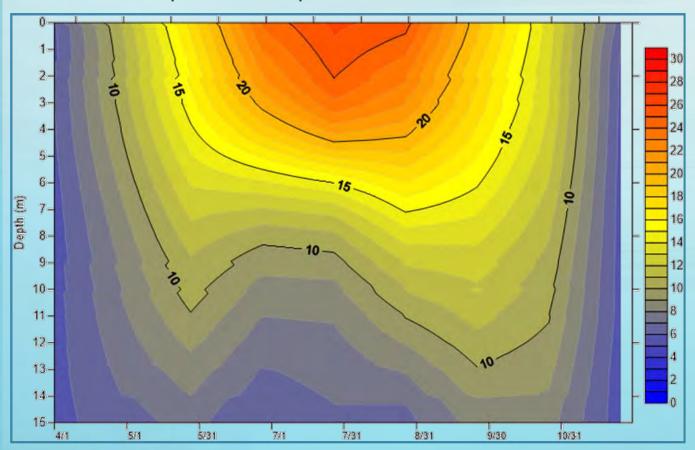
Lake Waccabuc Dissolved Oxygen & Temperature

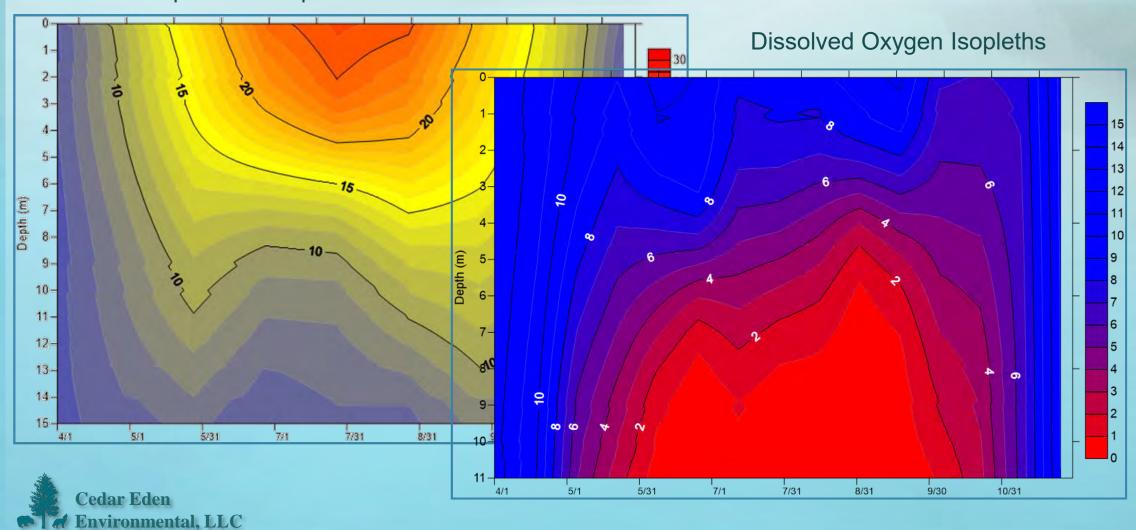
Lake Waccabuc Dissolved Oxygen & Temperature

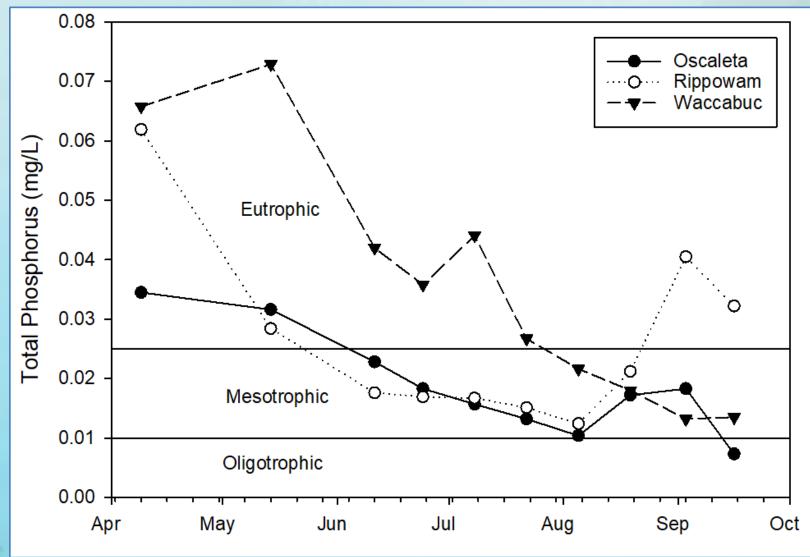
Total Phosphorus (epilimnia)

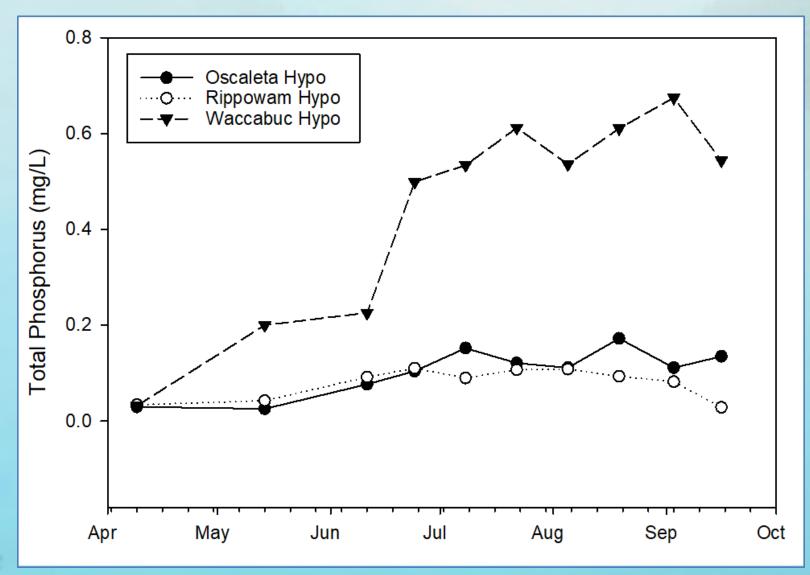
Total Phosphorus (hypolimnia)

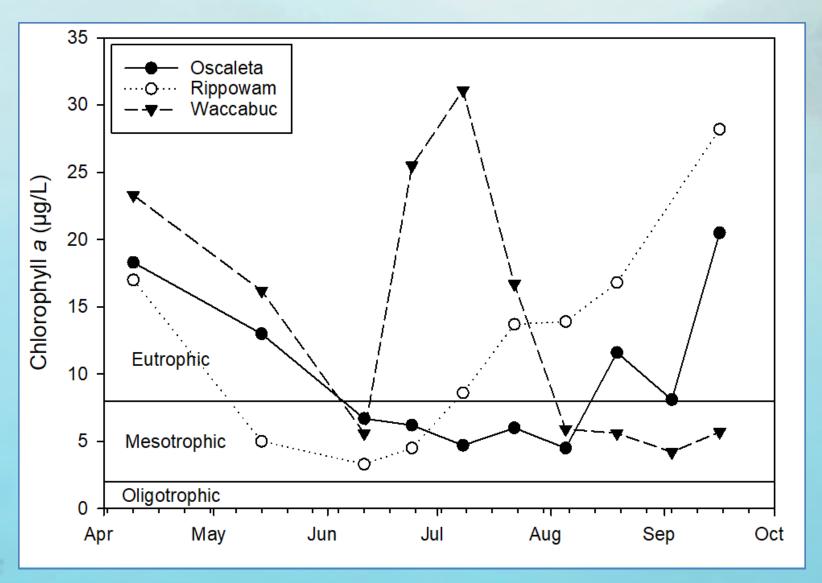
Chlorophyll a

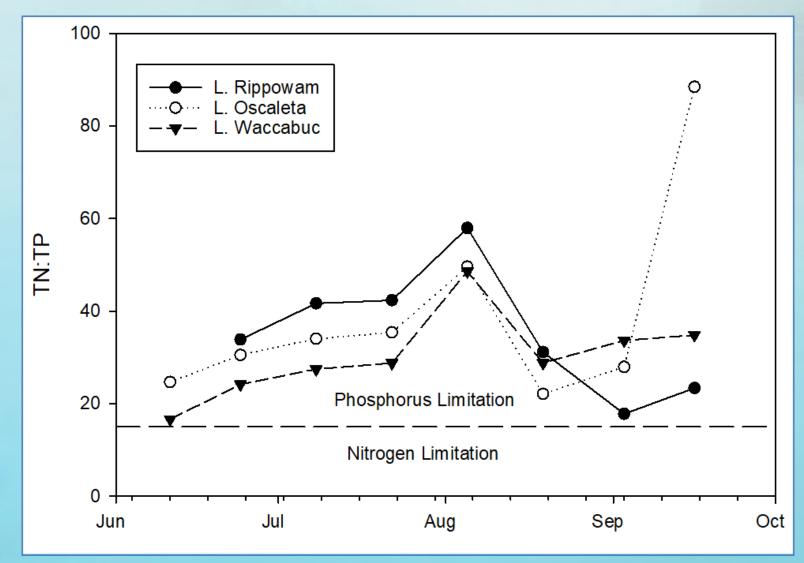
Limiting Nutrient

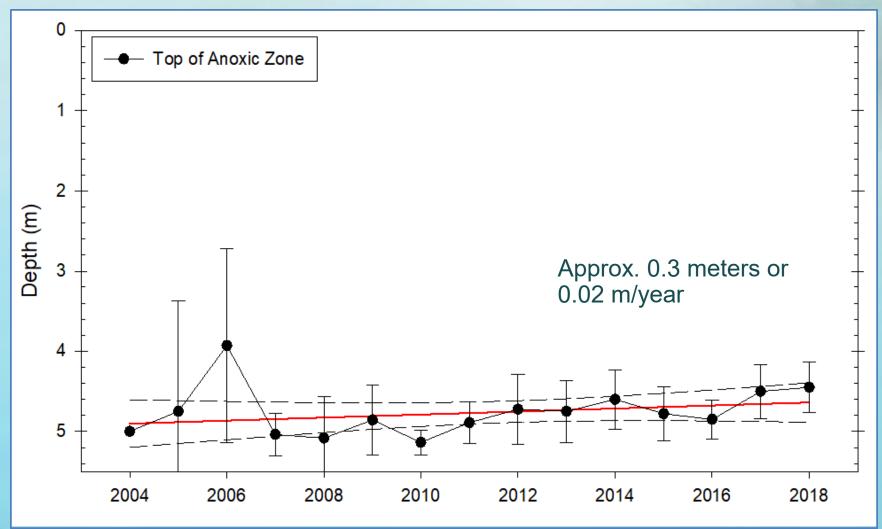
Lake Rippowam Anoxia Trend

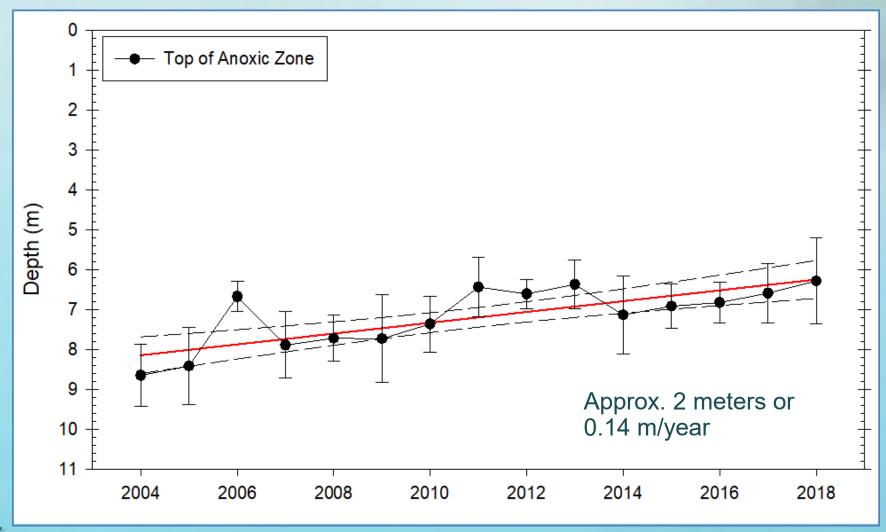
Lake Oscaleta Anoxia Trend

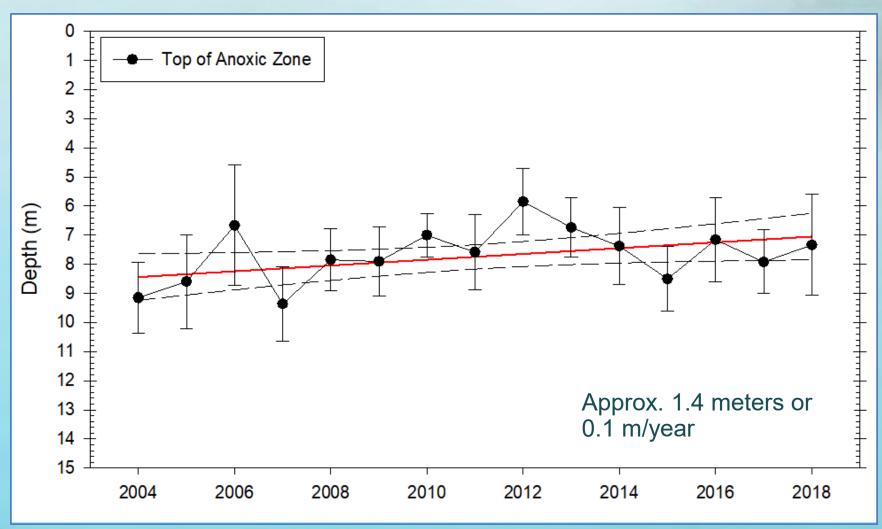
Lake Waccabuc Anoxia Trend

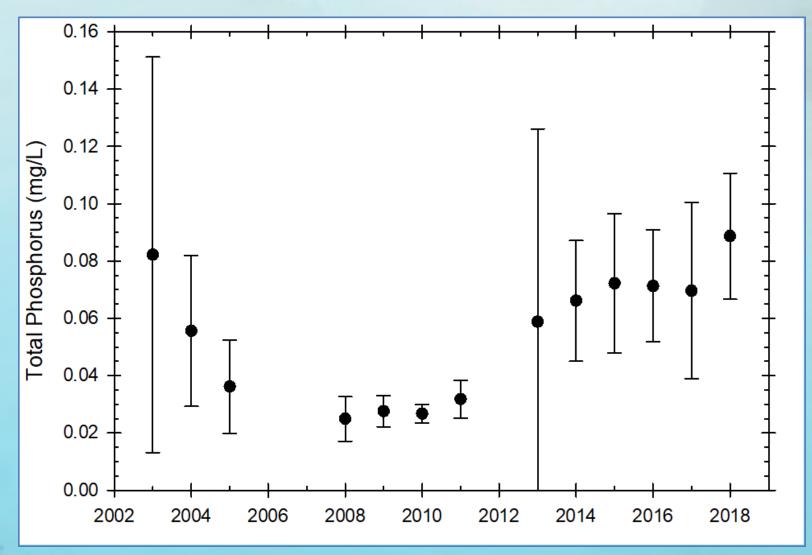
Lake Rippowam Hypolimnetic Total Phosphorus Trend

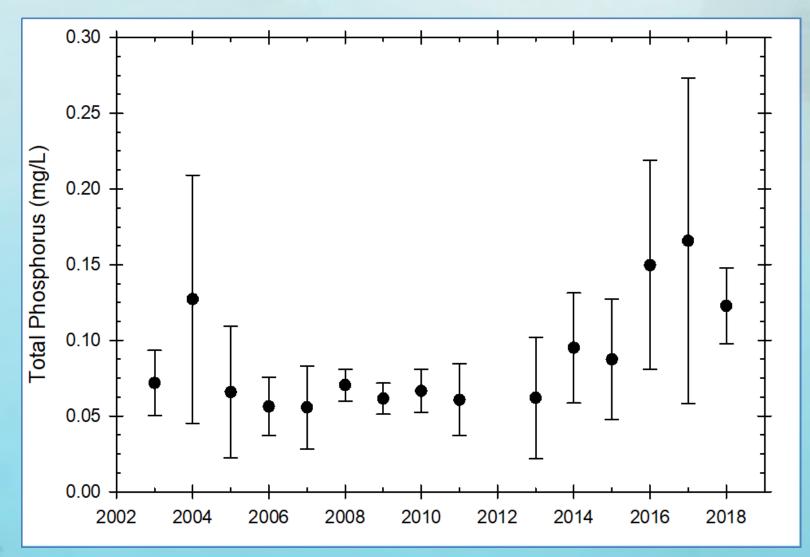
Lake Oscaleta Hypolimnetic Total Phosphorus Trend

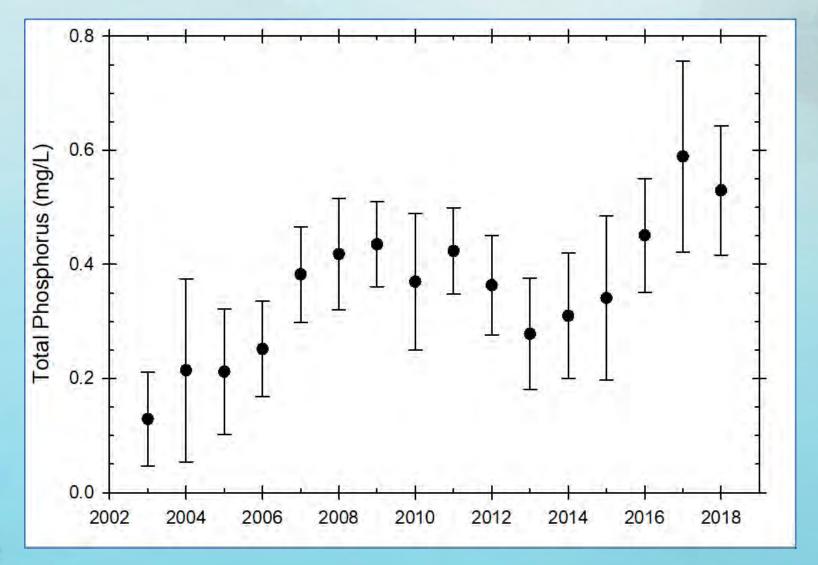
Lake Waccabuc Hypolimnetic Total Phosphorus Trend

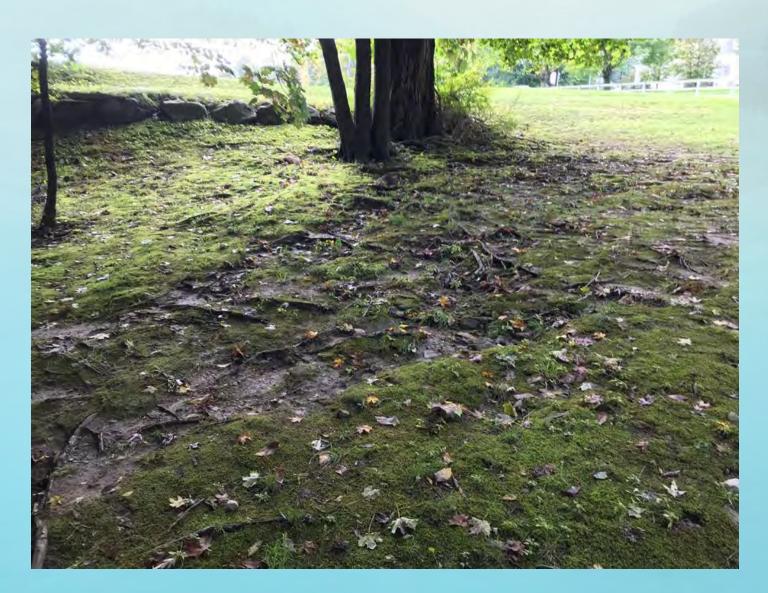
Mead Street/
Post Office Lot

Nonpoint Source Problems: Stormwater Runoff

- Install Stormwater Management measures at Mead Street and Post Office parking lot
- Install Stormwater Management measures and replace aggregate on Tarry-A-Bit and Old Pond Roads
- Reduce residential runoff using rain barrels and rain gardens (infiltration)
- Seek alternative anti-corrosion method for water supply
 - HABs study recommends targeting dissolved bio-available forms of phosphorus

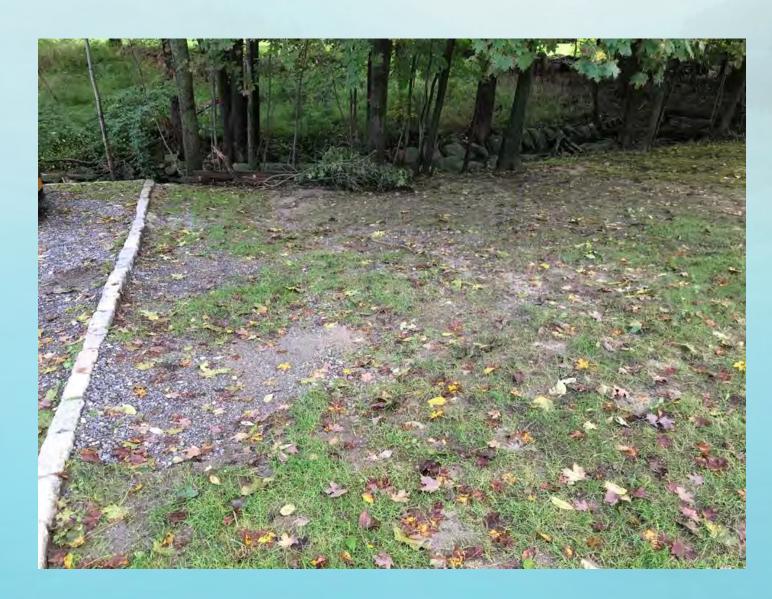
Mead Street/
Post Office Lot

Nonpoint Source Problems: Stormwater Runoff

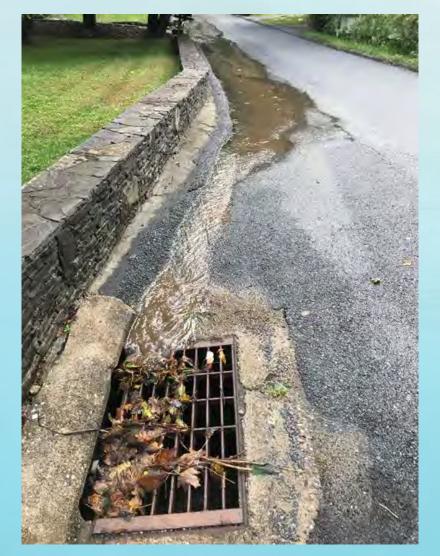
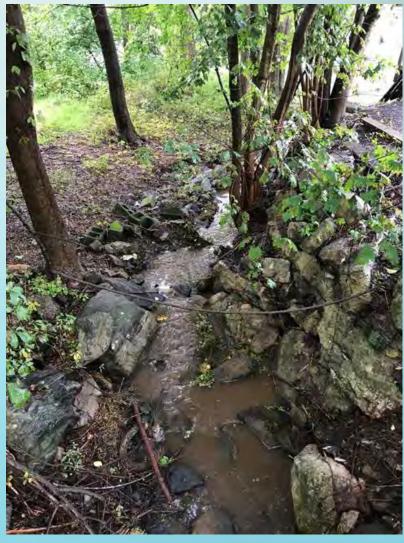
Lakeview Road

Nonpoint Source Problems: Stormwater Runoff

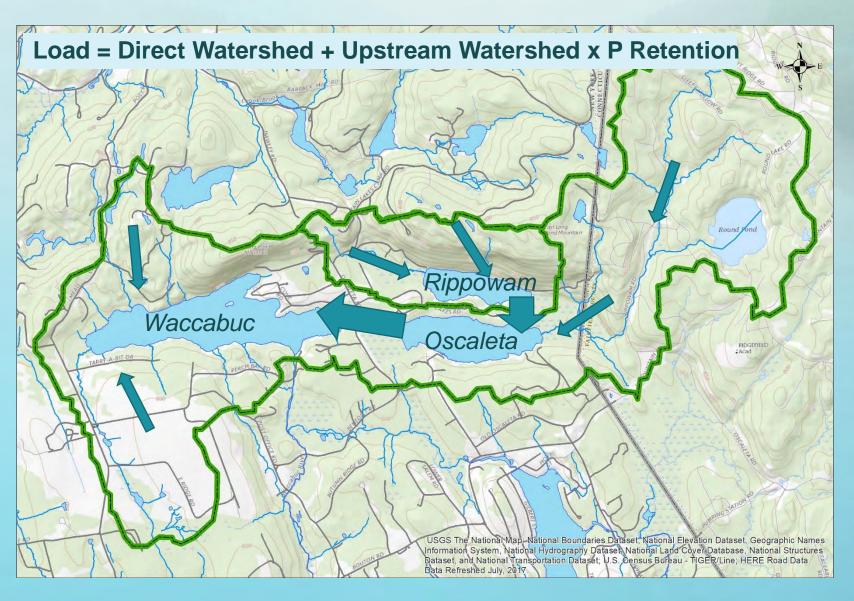
Calculating Pollutant Budgets for Lake Chains

- Rippowam 279 acres
- Oscaleta 1,282 acres
- Waccabuc 2,196 acres

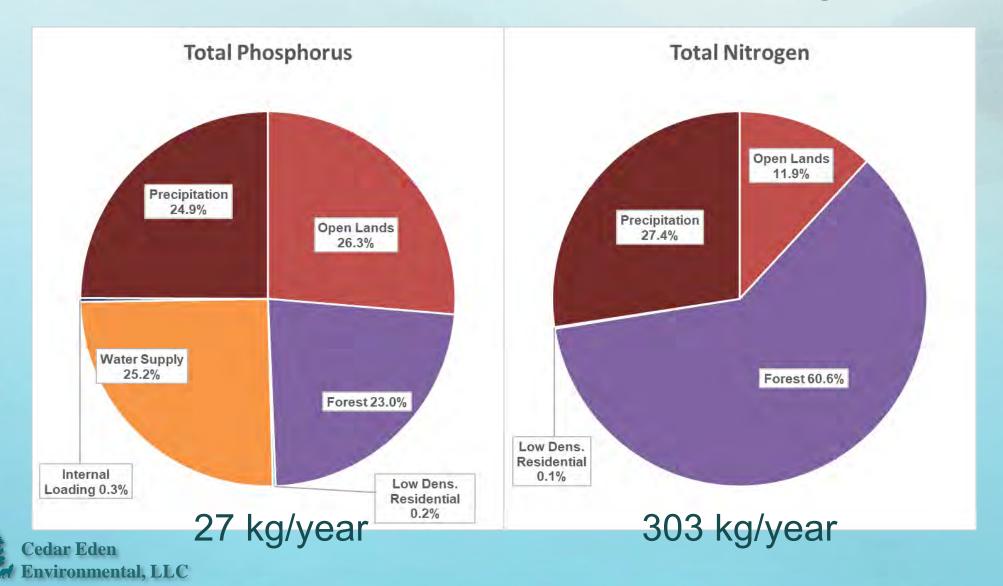
Lake Rippowam Annual Pollutant Budgets

Nutrient Budget Calculations and Results for Lake Rippowam Watershed								
	Area	Loading Coefficients (kg/ha/yr)		Annual Load (kg/year)		Annual Load (Percent)		
Land Use	(ha)	TP	TN	TP	TN	TP	TN	
Open Water	14.45			0.0	0.0	0.0%	0.0%	
Open Lands	6.54	1.1	5.5	7.2	36.0	26.3%	11.9%	
Mod./High Dens. Residential	0.00	1.1	5.5	0.0	0.0	0.0%	0.0%	
Forest	91.77	0.0685	2.0	6.3	183.5	23.0%	60.6%	
Low Dens. Residential	0.00	0.725	4.335	0.1	0.4	0.2%	0.1%	
Water Supply				6.9		25.2%	0.0%	
Internal Loading				0.1		0.3%	0.0%	
Precipitation	14.45	0.4715	5.75	6.8	83.1	24.9%	27.4%	
Totals				27.3	303.0	100%	100%

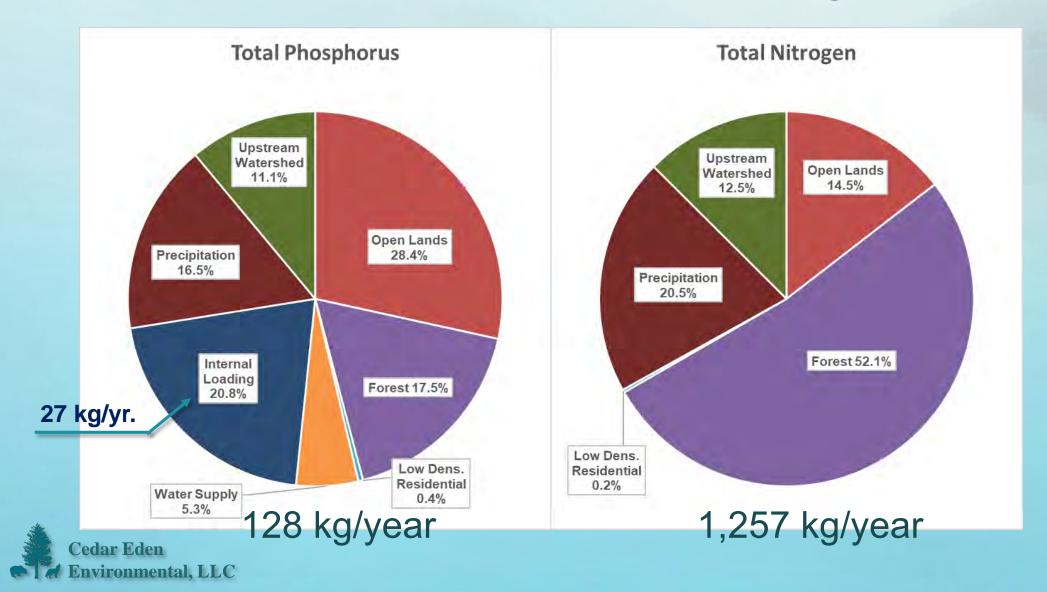
Lake Oscaleta Annual Pollutant Budgets

Nutrient Budget Calculations and Results for Lake Oscaleta Watershed									
	Area	Loading Coefficients (kg/ha/yr)		Annual Load (kg/year)		Annual Load (Percent)			
Land Use	(ha)	TP	TN	TP	TN	TP	TN		
Open Water	44.87			0.0	0.0	0.0%	0.0%		
Open Lands	33.22	1.1	5.5	36.5	182.7	28.4%	14.5%		
Mod./High Dens. Residential	0.00	1.1	5.5	0.0	0.0	0.0%	0.0%		
Forest	327.68	0.0685	2.0	22.4	655.4	17.5%	52.1%		
Low Dens. Residential	0.72	0.725	4.335	0.5	3.1	0.4%	0.2%		
Water Supply				6.9		5.3%	0.0%		
Internal Loading				26.8		20.8%	0.0%		
Precipitation	44.87	0.4715	5.75	21.2	258.0	16.5%	20.5%		
Upstream Watershed				14.2	157.6	11.1%	12.5%		
Totals				128.5	1256.7	100%	100%

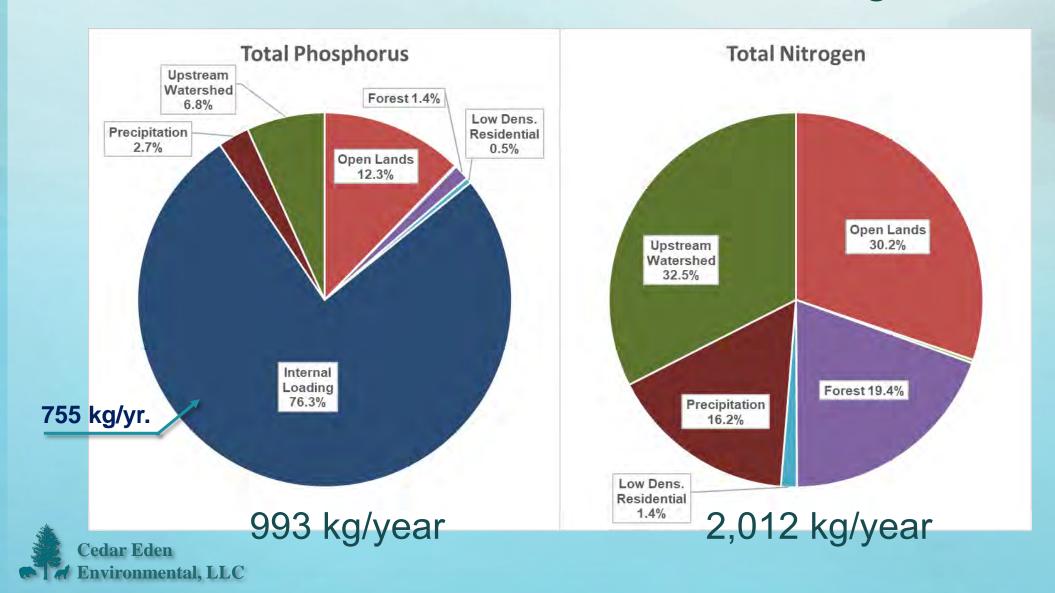
Lake Waccabuc Annual Pollutant Budgets

Nutrient Budget Calculations and Results for Lake Waccabuc Watershed									
	Area	Loading Coefficients (kg/ha/yr)		Annual Load (kg/year)		Annual Load (Percent)			
Land Use	(ha)	TP	TN	TP	TN	TP	TN		
Open Water	56.74			0.0	0.0	0.0%	0.0%		
Open Lands	110.44	1.1	5.5	121.5	607.4	12.3%	30.2%		
Mod./High Dens. Residential	1.09	1.1	5.5	1.2	6.0	0.1%	0.3%		
Forest	195.44	0.0685	2.0	13.4	390.9	1.4%	19.4%		
Low Dens. Residential	6.39	0.725	4.335	4.6	27.7	0.5%	1.4%		
Water Supply						0.0%	0.0%		
Internal Loading				755.0		76.3%	0.0%		
Precipitation	56.74	0.4715	5.75	26.8	326.2	2.7%	16.2%		
Upstream Watershed				66.8	653.5	6.8%	32.5%		
Totals				989.3	2011.7	100%	100%
