# Barton & Oguidice

# Lake Waccabuc

Engineering Study

July 28, 2021

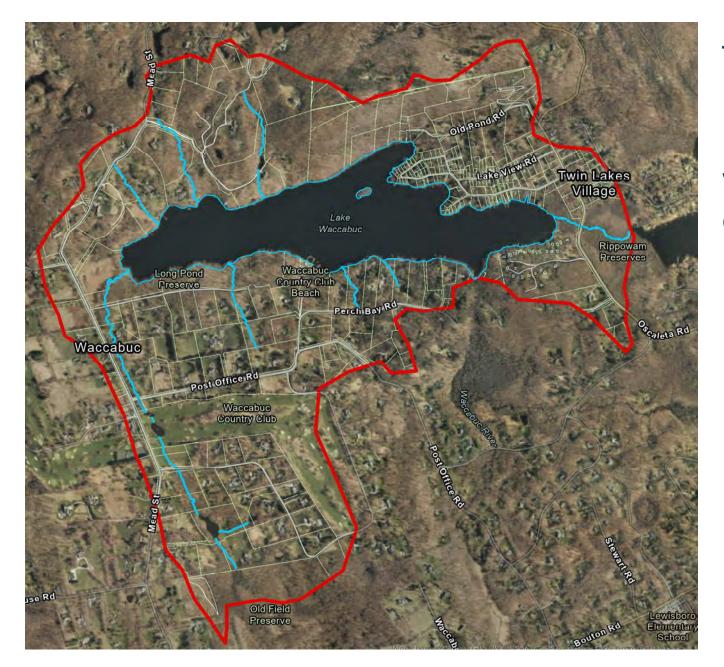
### Lake Waccabuc Study Area

The study area is made up of the Lake Waccabuc watershed, excluding Lake Rippowam and Lake Oscaleta.

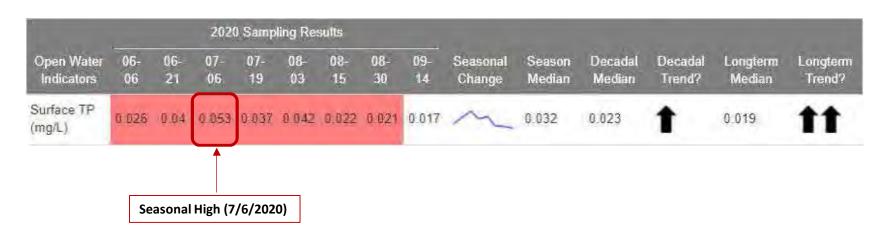
#### Lake Waccabuc - Lake Scorecard

Water Quality Indicators	Average Year	2020	
Phosphorus	Mesotrophic	Eutrophic	
Chlorophyll A	Mesotrophic	Eutrophic	
Secchi	Mesotrophic	Eutrophic	
Lake Perception	Good	Good	
Harmful Algal Blooms	Poor	Poor	
Open Water Algae Levels	Fair	Poor	
Aquatic Invasive Species	Present

- Water quality data is collected through the Citizen Statewide Lake Assessment Program (CSLAP)
- CSLAP shows significant increase in phosphorus levels since 1986
- 2020 CSLAP data identified peak phosphorus concentrations of 0.053 mg/L
  - Over 2x greater than the NYS recommended limit (0.020 mg/L)
- 2020 CSLAP data suggests Lake Waccabuc is approaching a eutrophic condition

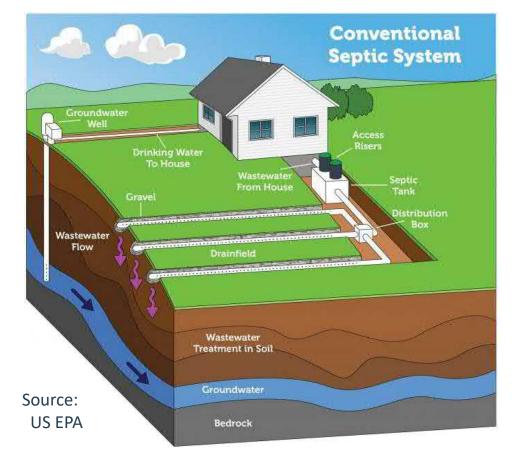
### **Poorly Functioning Septic Systems**

Examples of conditions that may cause a septic system to perform poorly may include:

- Aging System Components
- Site Environmental Constraints

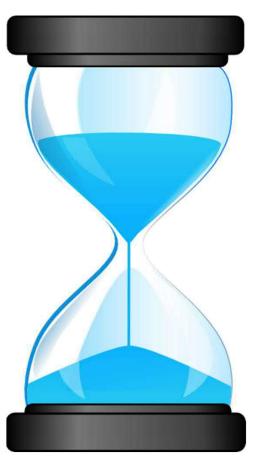
### **Aging Septic Systems**

- The limiting components of a septic system have a life expectancy of **50 years**.
- The USEPA states that "the average lifespan of a septic system is **15 to 40 years**, but it can last longer if properly maintained."
- The Cornell Cooperative Extension states that "[septic] systems are designed to have a useful life of 20 to 30 years under the best conditions."

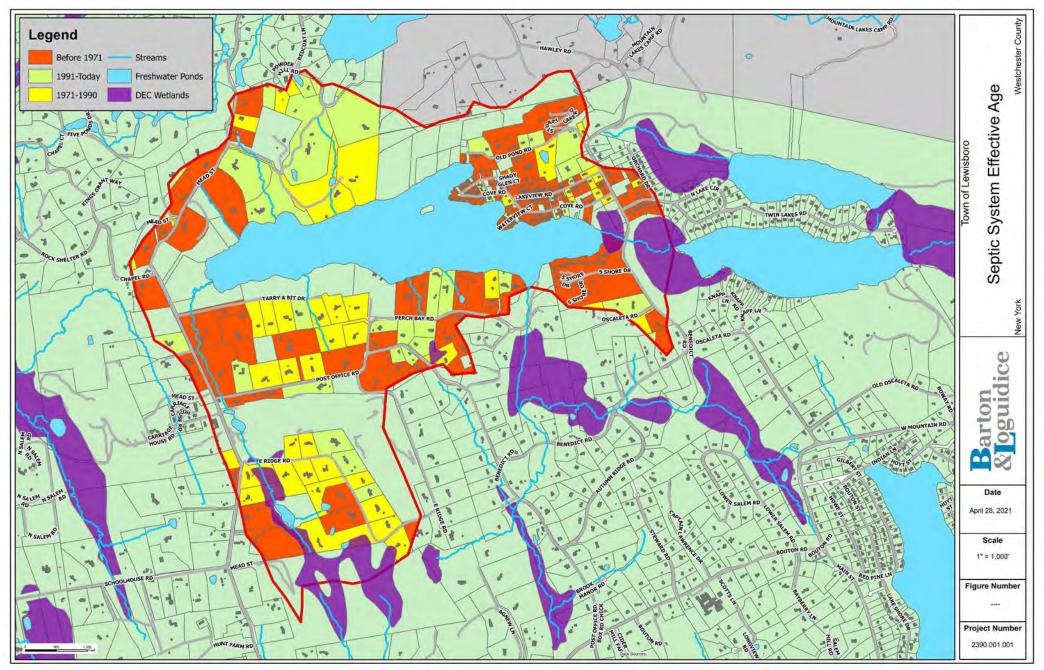
### **Aging Septic Systems**

- Any septic system estimated to be 50 years or older is assumed to be poorly functioning
- Any septic system estimated to be 30 to 49 years old, without record of regular septic pump-outs is assumed to be poorly functioning

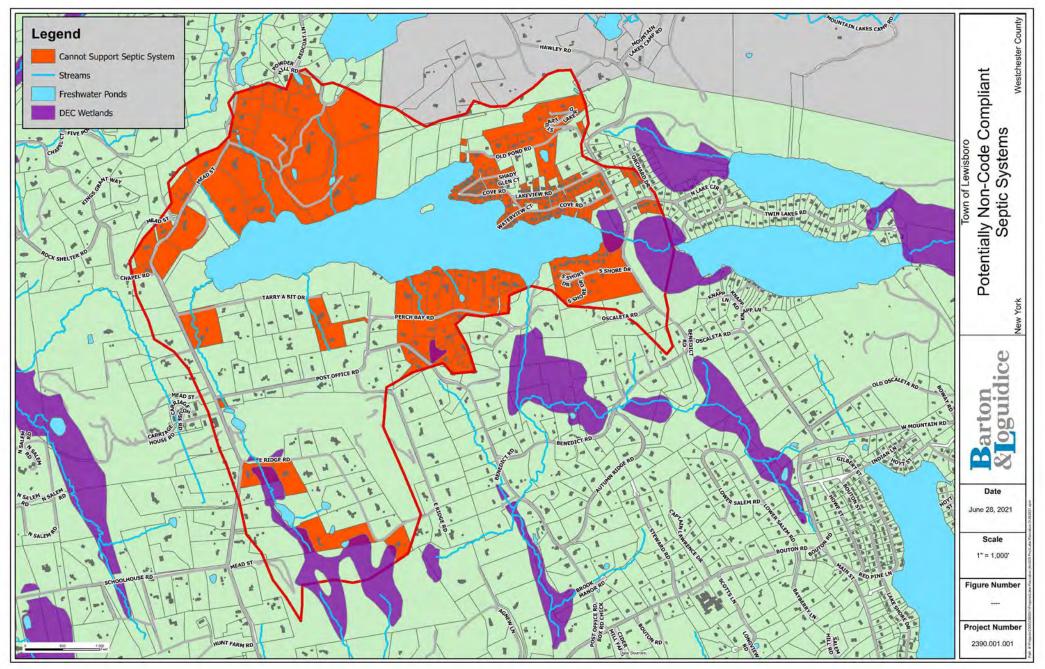
### **Site Environmental Constraints**

Any septic system that likely does not meet the current Health Code standards is assumed to be poorly functioning.

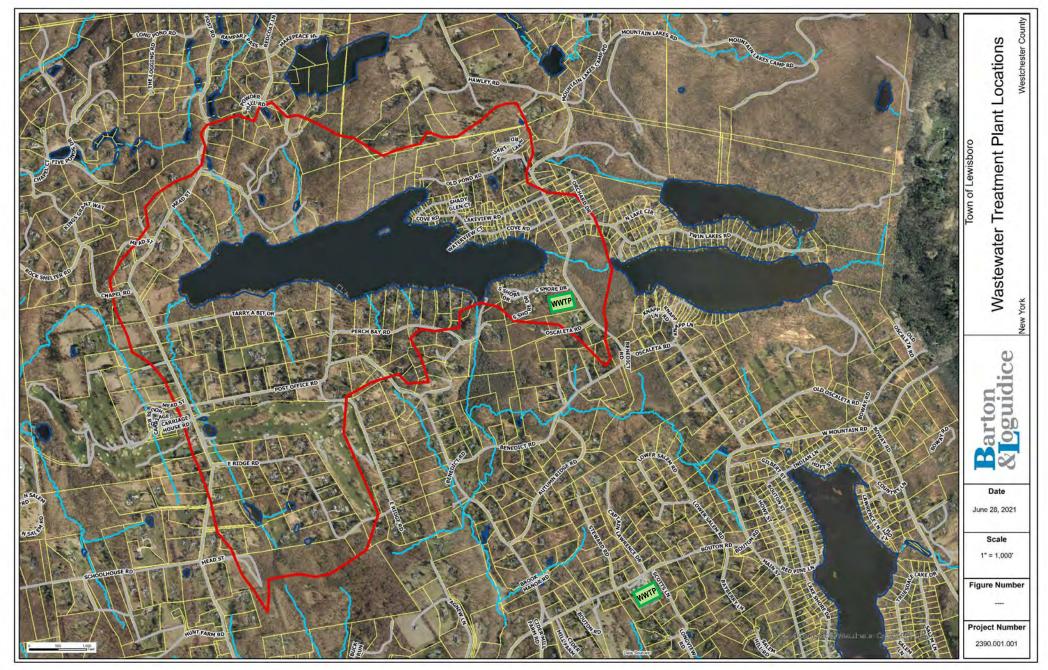
### **Sewer to New WWTP**

- There is limited land available to build a WWTP
  - It would take ~ 0.5 acres to treat the entire study area
- There are 2 sites under consideration:
  - South Shore Association Limited Capacity
  - Lewisboro Elementary School Combined with Truesdale Lake community

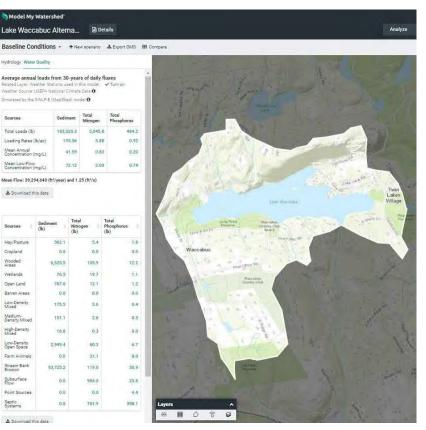
### **Existing Nutrient Loads by Source**

Model results indicate septic system failure contributes: ~81% of existing external phosphorus (P) load ~36% of existing external nitrogen (N) load

Sediment	Total Nitrogen	Total Phosphorus
Sources	(lb)	(lb)	(lb)
Hay/Pasture	562.1	5.4	1.8
Cropland	0	0	0
Wooded Areas	6,525.5	105.9	12.2
Wetlands	76.5	19.7	1.1
Open Land	787.6	12.1	1.2
Barren Areas	0	0	0
Low-Density Mixed	175.5	3.6	0.4
Medium-Density Mixed	151.1	2.8	0.3
High-Density Mixed	16.8	0.3	0
Low-Density Open Space	2,949.4	60.3	6.7
Farm Animals	0	31.1	8
Stream Bank Erosion	93,725.2	119	30.9
Subsurface Flow	0	984	25.8
Point Sources	0	0	4.4
Septic Systems	0	761.9	398.1
TOTAL	104,969.7	2,106.1	490.9
