# Lake Waccabuc Engineering Study Wastewater Issues and Solutions

NEIWPCC Project Code: 2020-024

**Town of Lewisboro**

Final Engineering Report

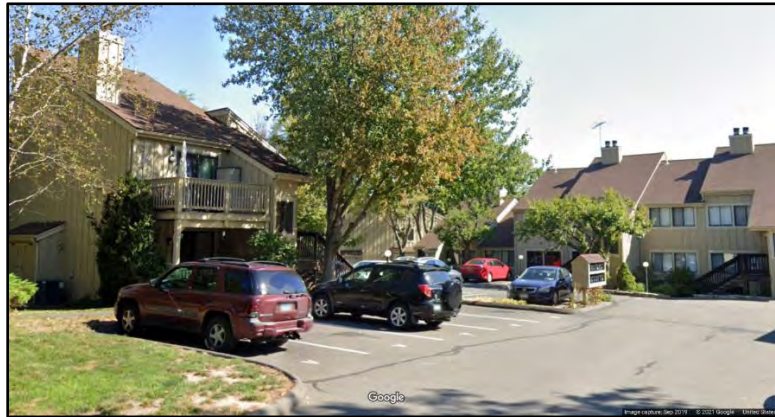
**Image 10-1: Oakridge Condominiums**

A good example of a local, similarly sized facility is the WRRF that supports the Oakridge Condominiums, located at 400 Oakridge Drive in South Salem. This WRRF was designed to blend in with the neighboring buildings, as is shown in the images that follow.

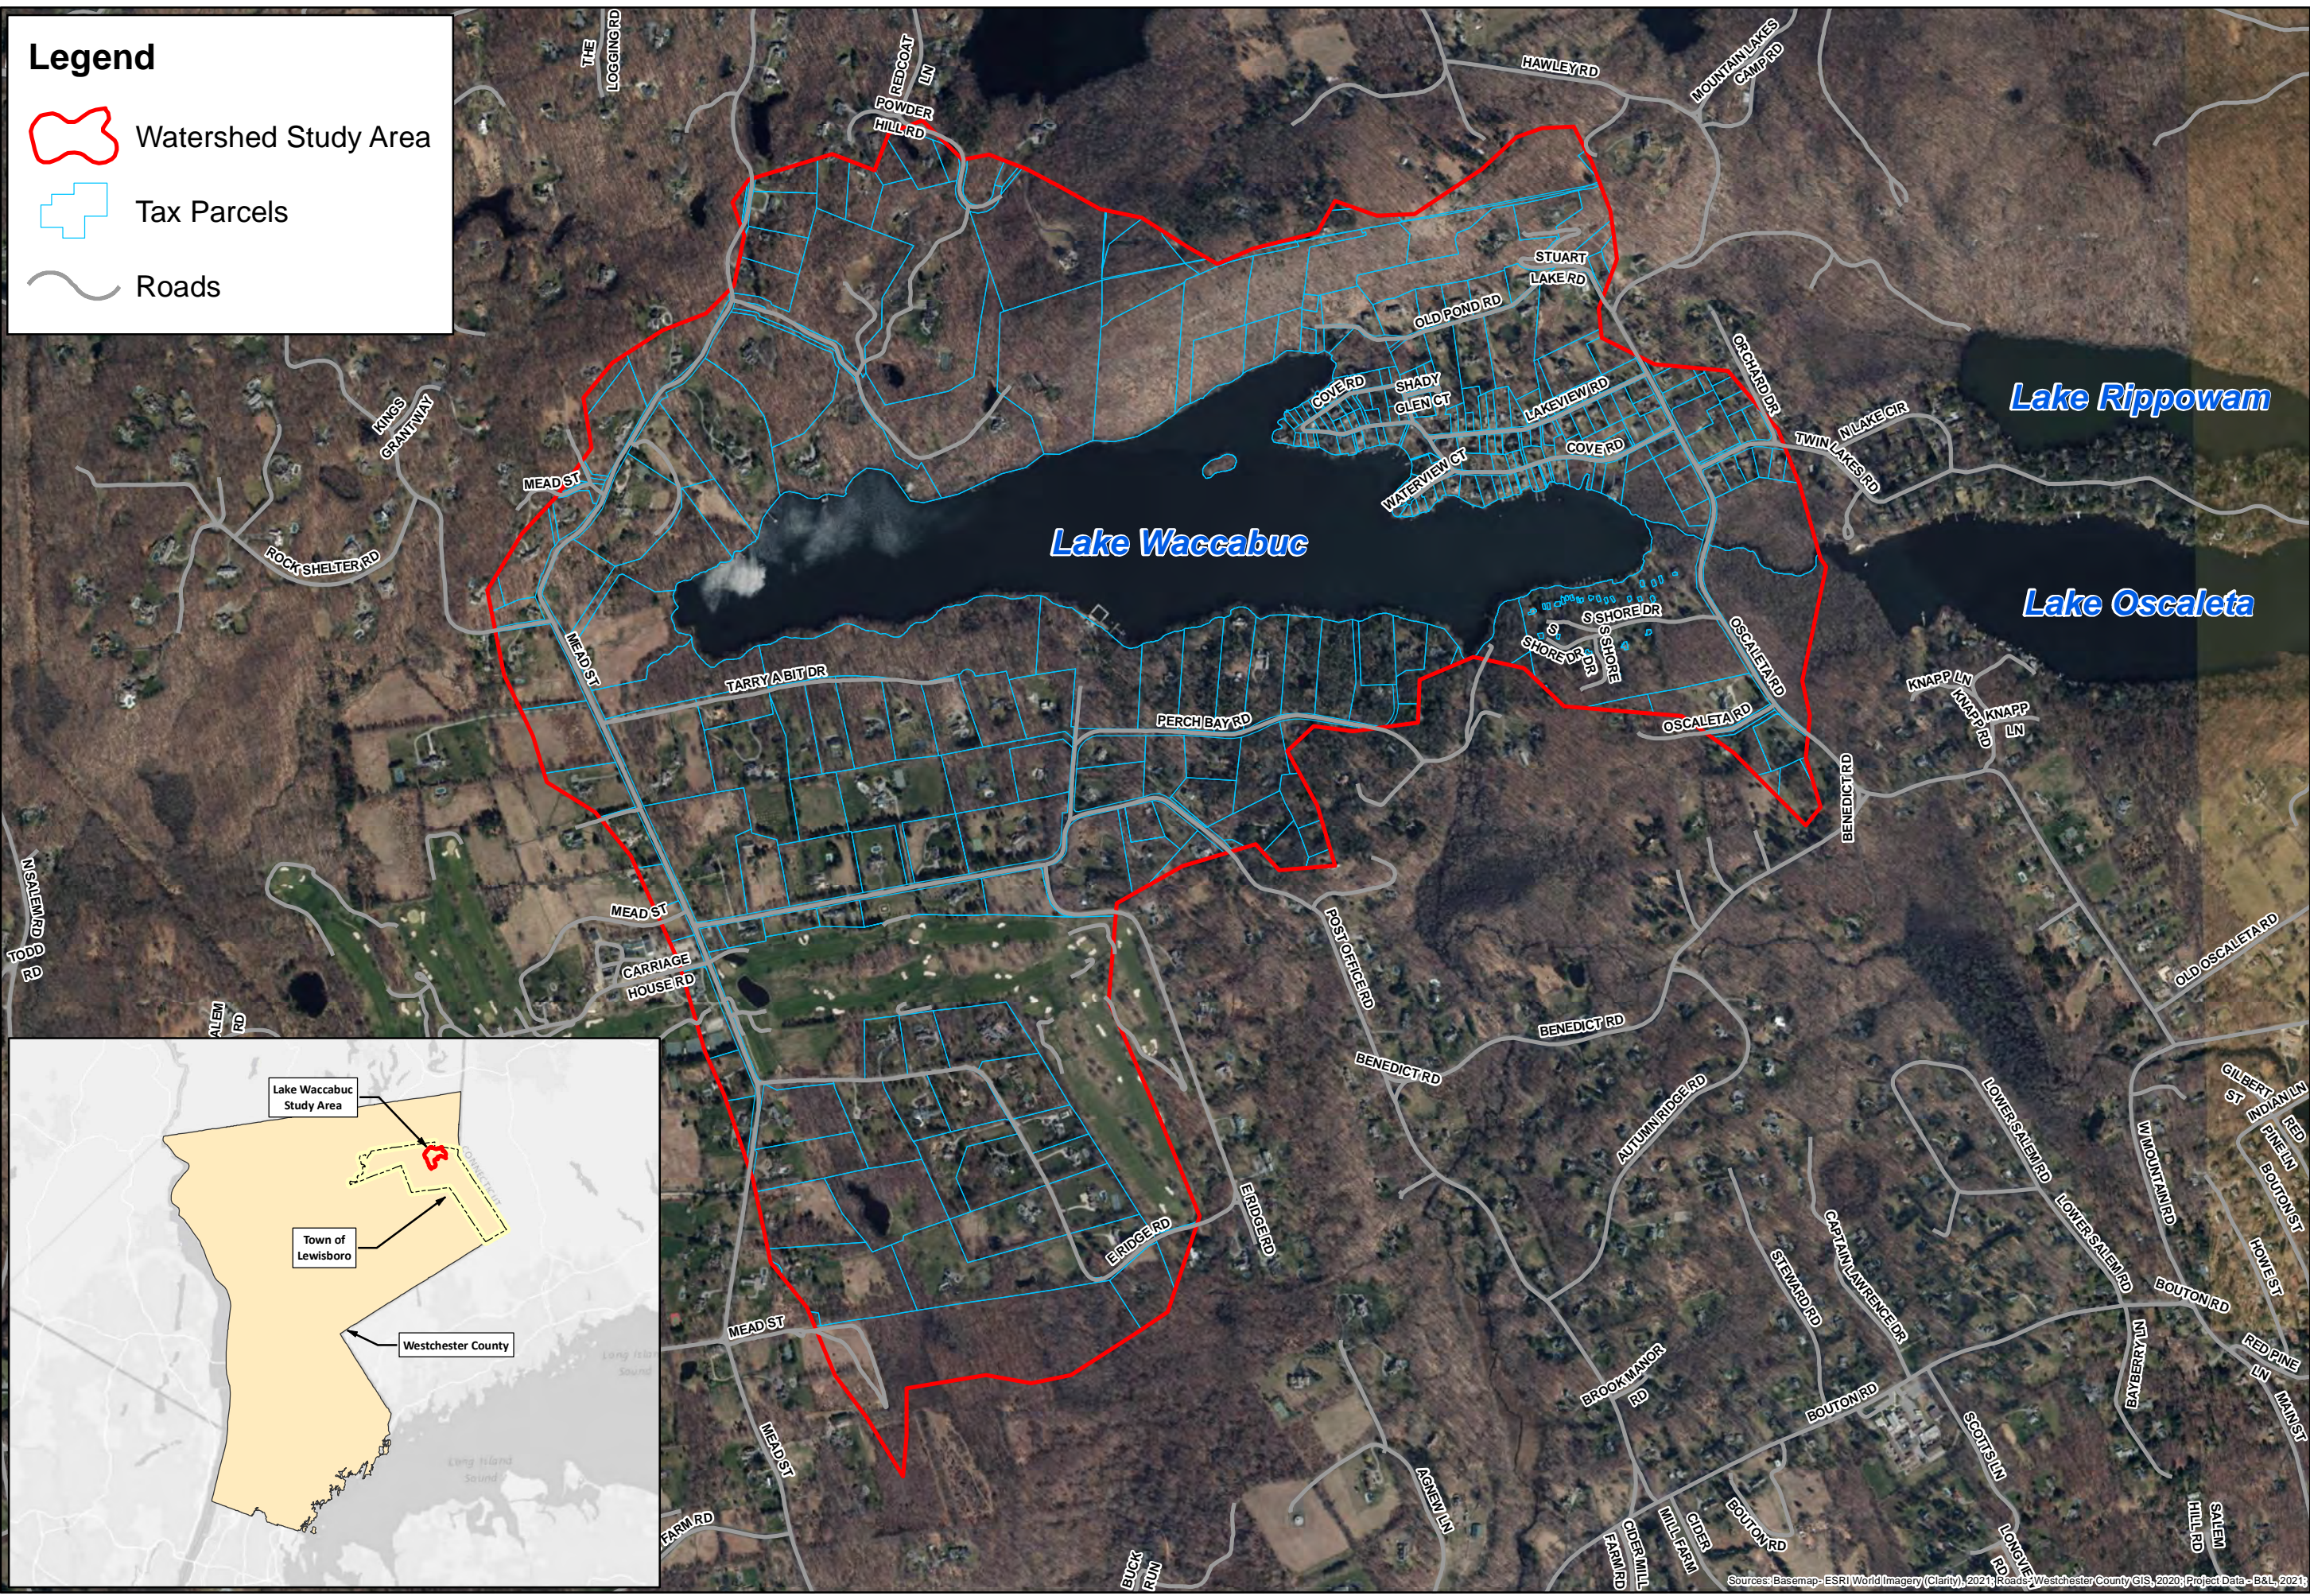
<b>Date</b>	July 2021
<b>Scale</b>	1" = 1000'
<b>Figure Number</b>	1-2
<b>Project Number</b>	2390.001

Town of Lewisboro  
 Aerial Study Area Map  
 Westchester County  
 August 2021  
 New York

The Town does not currently have a publicly owned sanitary sewer collection and treatment system in this area. Instead, it consists of individual on-site systems that are maintained by the property owners. Many of these systems have failed or are assumed to be failing based on our evaluation criteria. Considering the proximity of potentially failing septic systems to the Lake, a public sewer and treatment system would be an appropriate solution to serve the properties within the Study Area. The Study Area, consisting of drainage areas directly contributing runoff to Lake Waccabuc, is illustrated on Figure 1-1 (Topographic) and Figure 1-2 (Aerial).

The Study Area includes the areas directly contributing runoff to Lake Waccabuc, as shown on Figure 1-1 and Figure 1-2. The location of the Study Area in Westchester County is shown in Figure 2-2. Lake Waccabuc receives discharge from the upstream watersheds of Lake Rippowam and Lake Osaleta, however the Study Area evaluated for this project does not include these upstream lake areas. Contributing drainage areas within the Study Area vary in geologic conditions (*e.g.*, soil type, depth to bedrock, groundwater level, and slope). The physical and environmental characteristics were

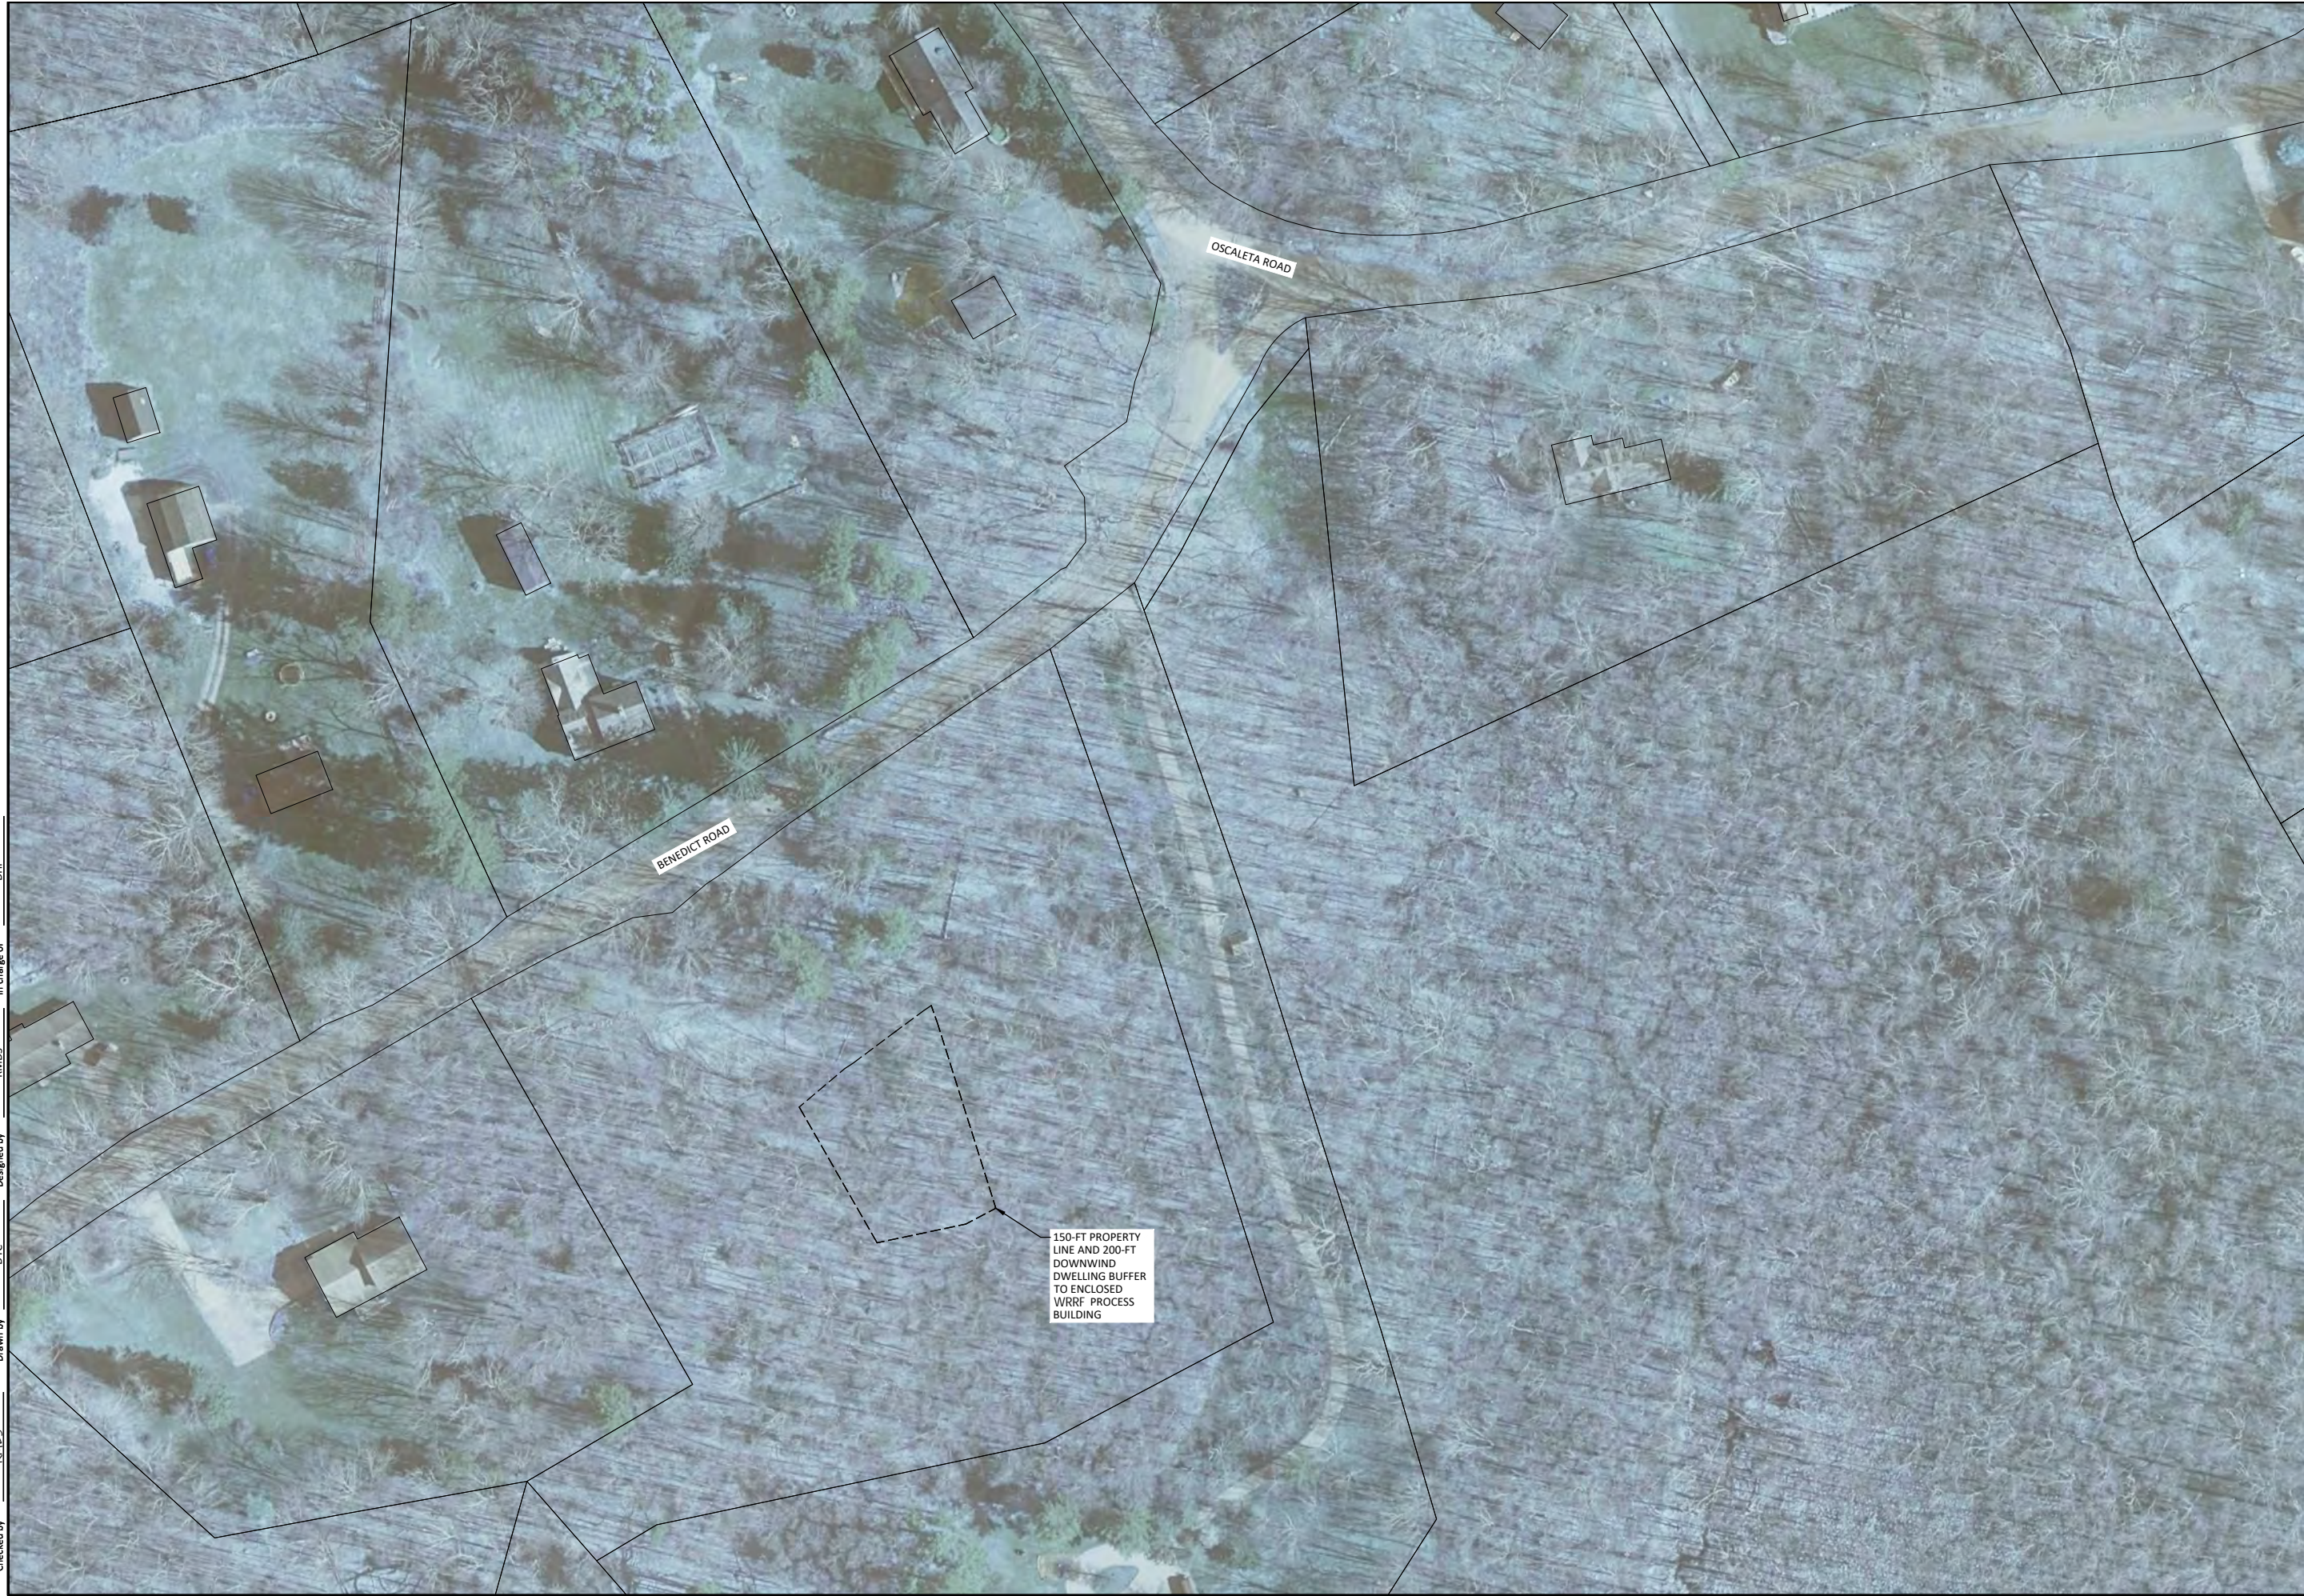
150-FT PROPERTY  
 LINE AND 200-FT  
 DOWNWIND  
 DWELLING BUFFER  
 TO ENCLOSED  
 WRRF PROCESS  
 BUILDING

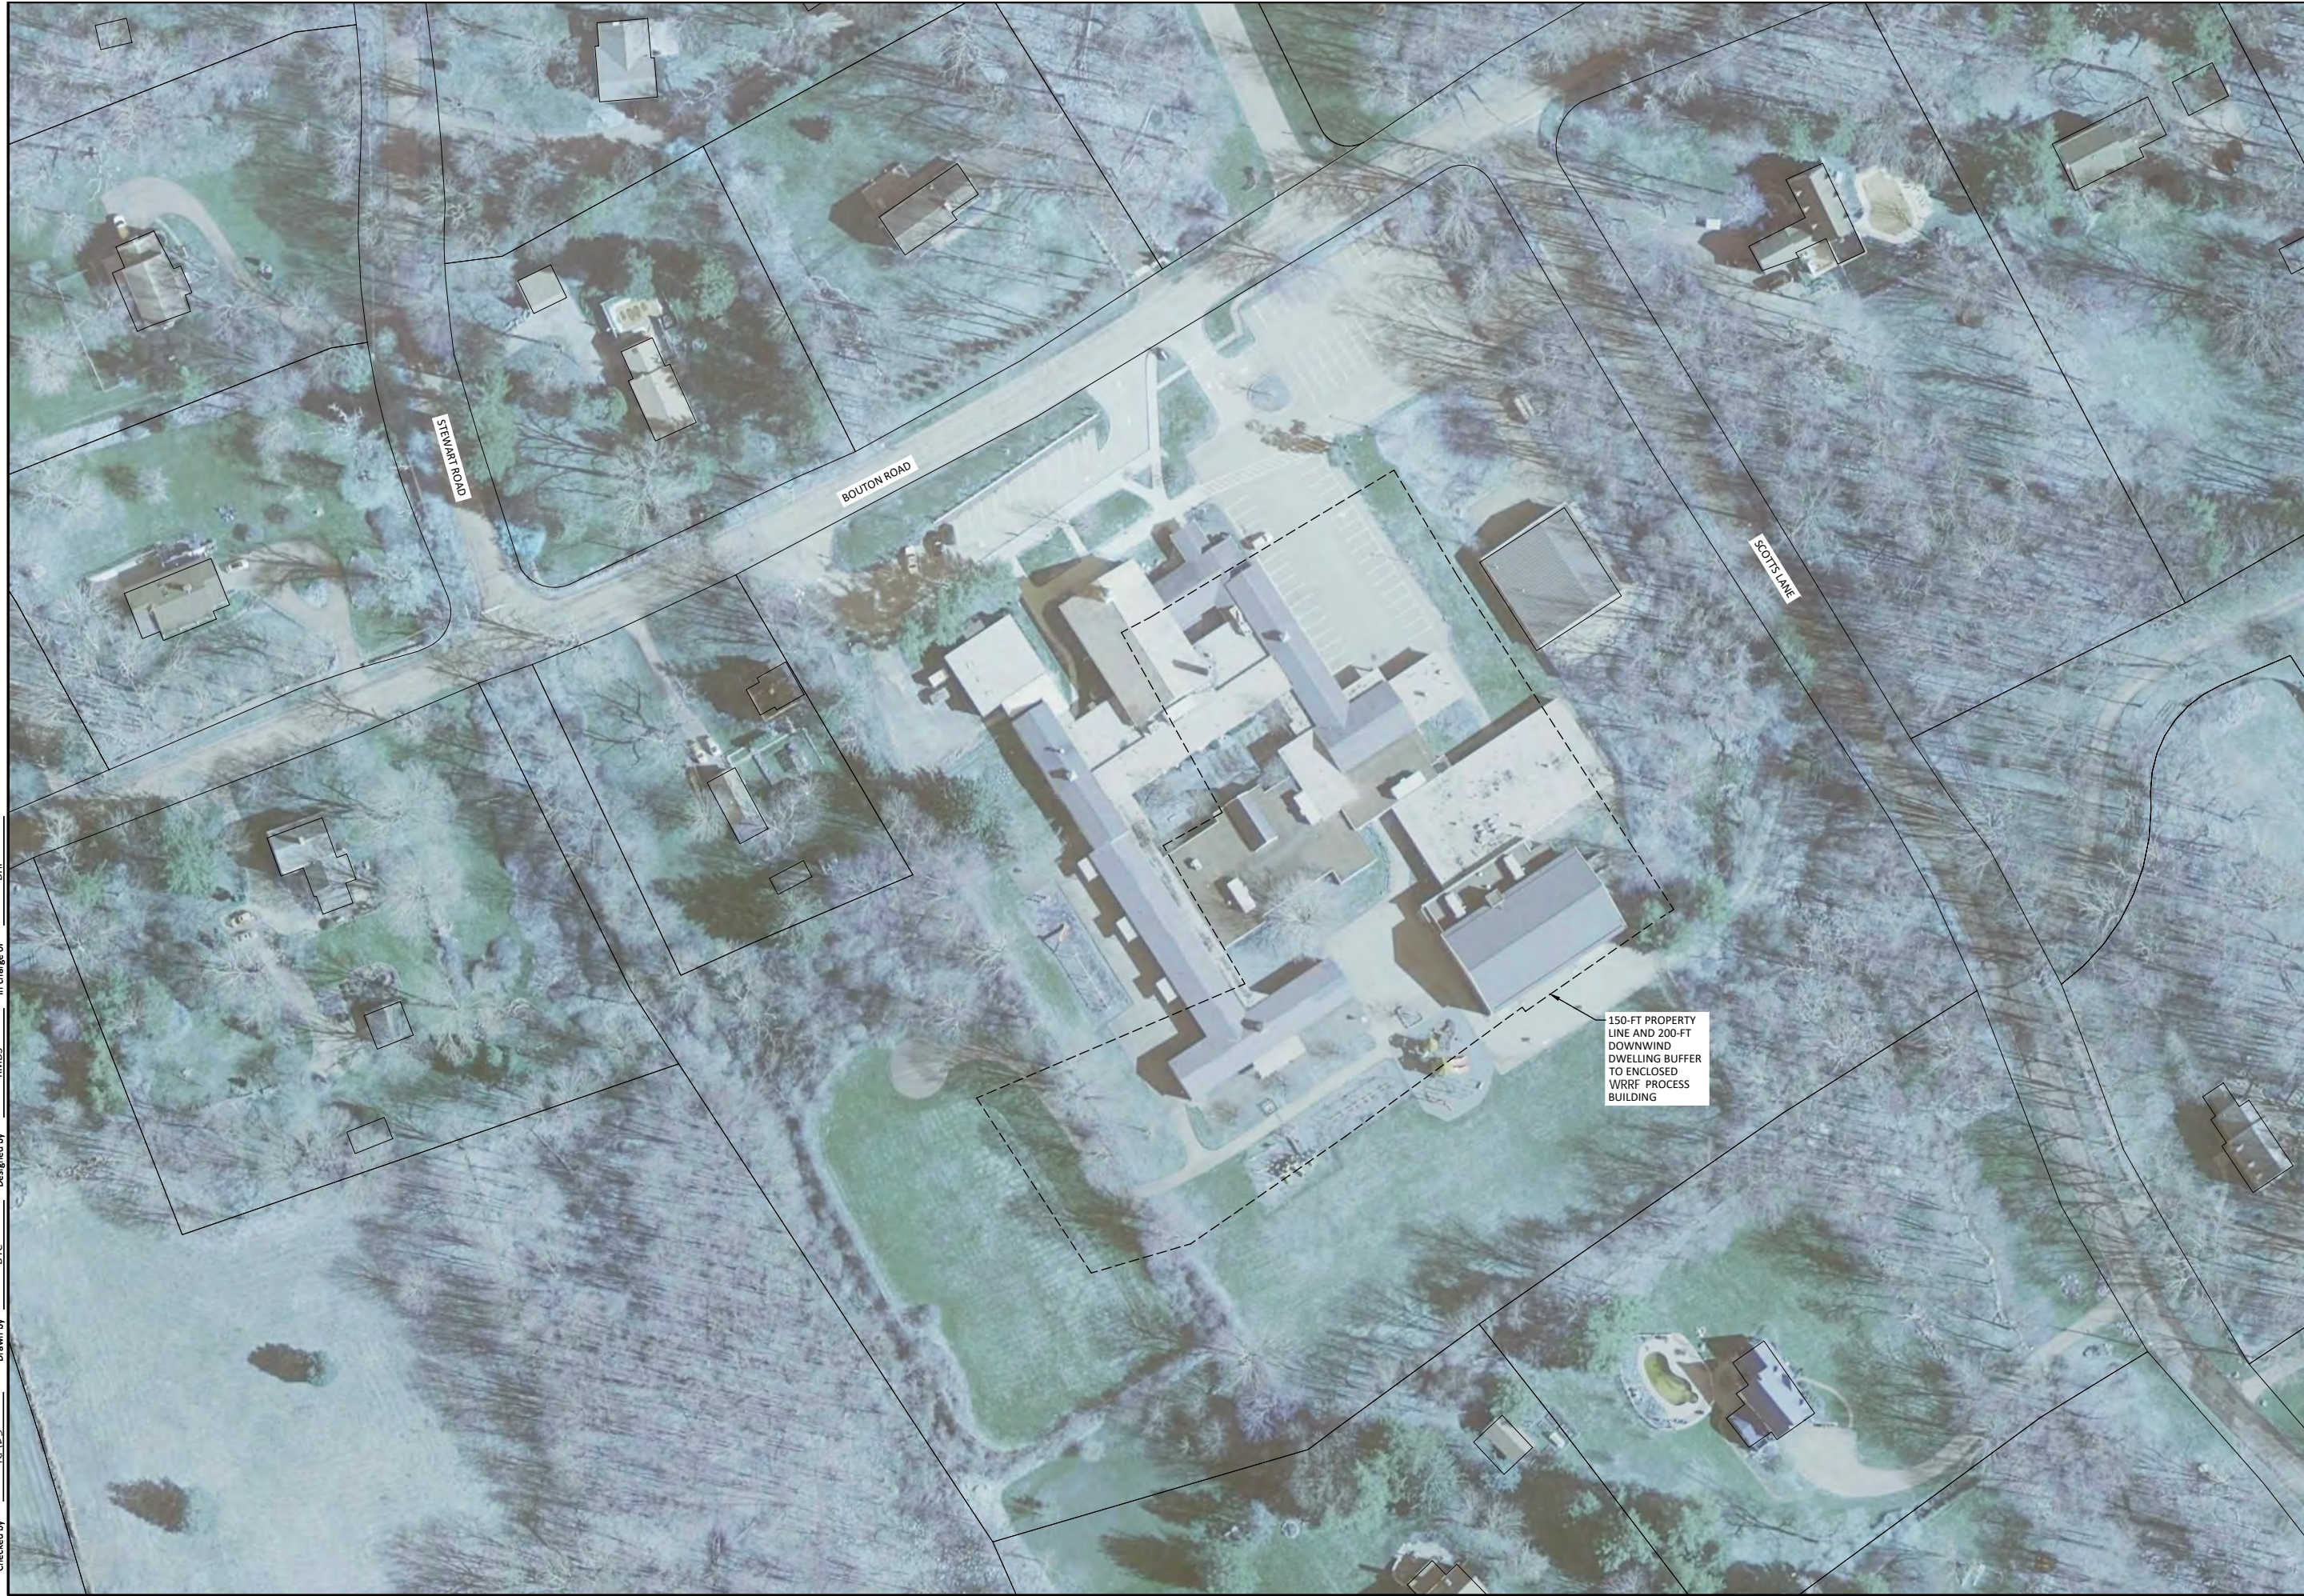
Date	AUGUST, 2021
Scale	AS SHOWN
Sheet Number	6-5
Project Number	2390.001.001

150-FT PROPERTY LINE AND 200-FT DOWNWIND DWELLING BUFFER TO ENCLOSED WRRF PROCESS BUILDING

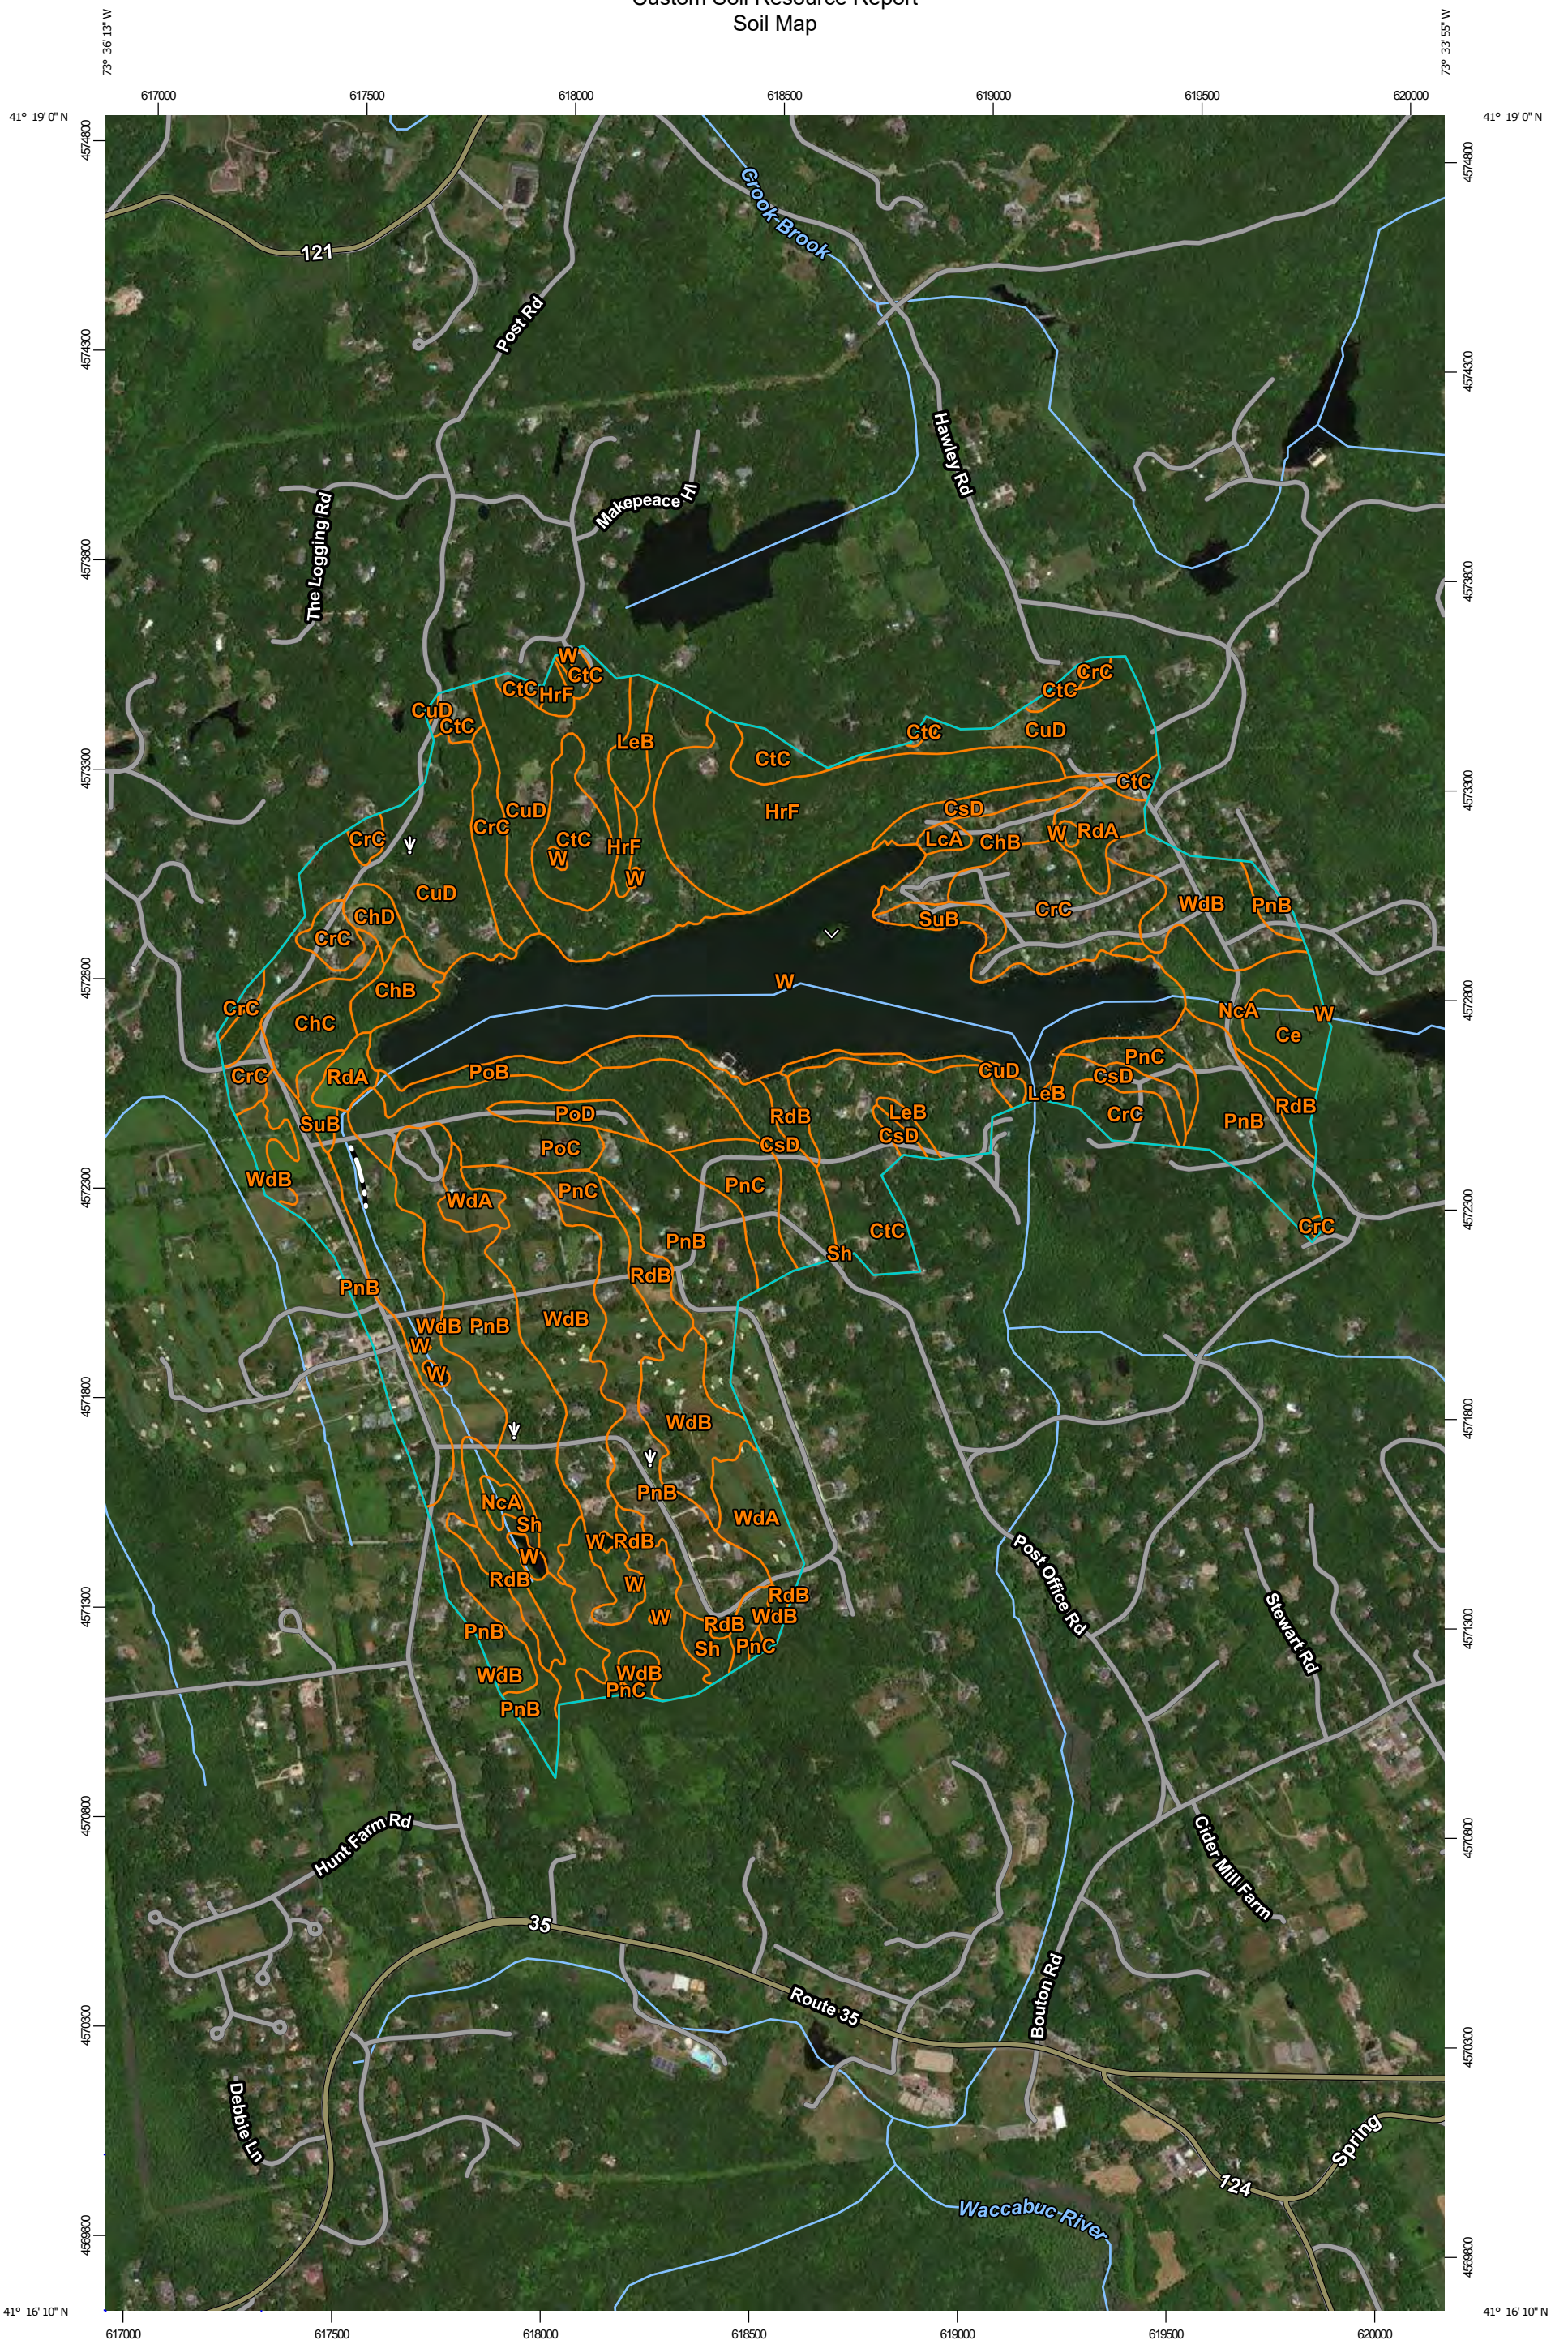
Custom Soil Resource Report  
Soil Map

The soil map section includes the soil map for the defined area of interest, a list of soil map units on the map and extent of each map unit, and cartographic symbols displayed on the map. Also presented are various metadata about data used to produce the map, and a description of each soil map unit.

Preliminary screening conducted through the USDA Web Soil Survey identified the type of soils found in the project area. The soils throughout the project area primarily consists of Paxton fine sandy loam, 3 to 8 percent slopes (PnB, 19.0%), Woodbridge loam, 3 to 8 percent slopes (WdB, 14.6%), and Chatfield-Hollis-Rock outcrop complex, 15 to 35 percent slopes (HrF, 14.5%) (Web Soil Survey, 2021). A full list of soils located within the project area is provided in Appendix B.

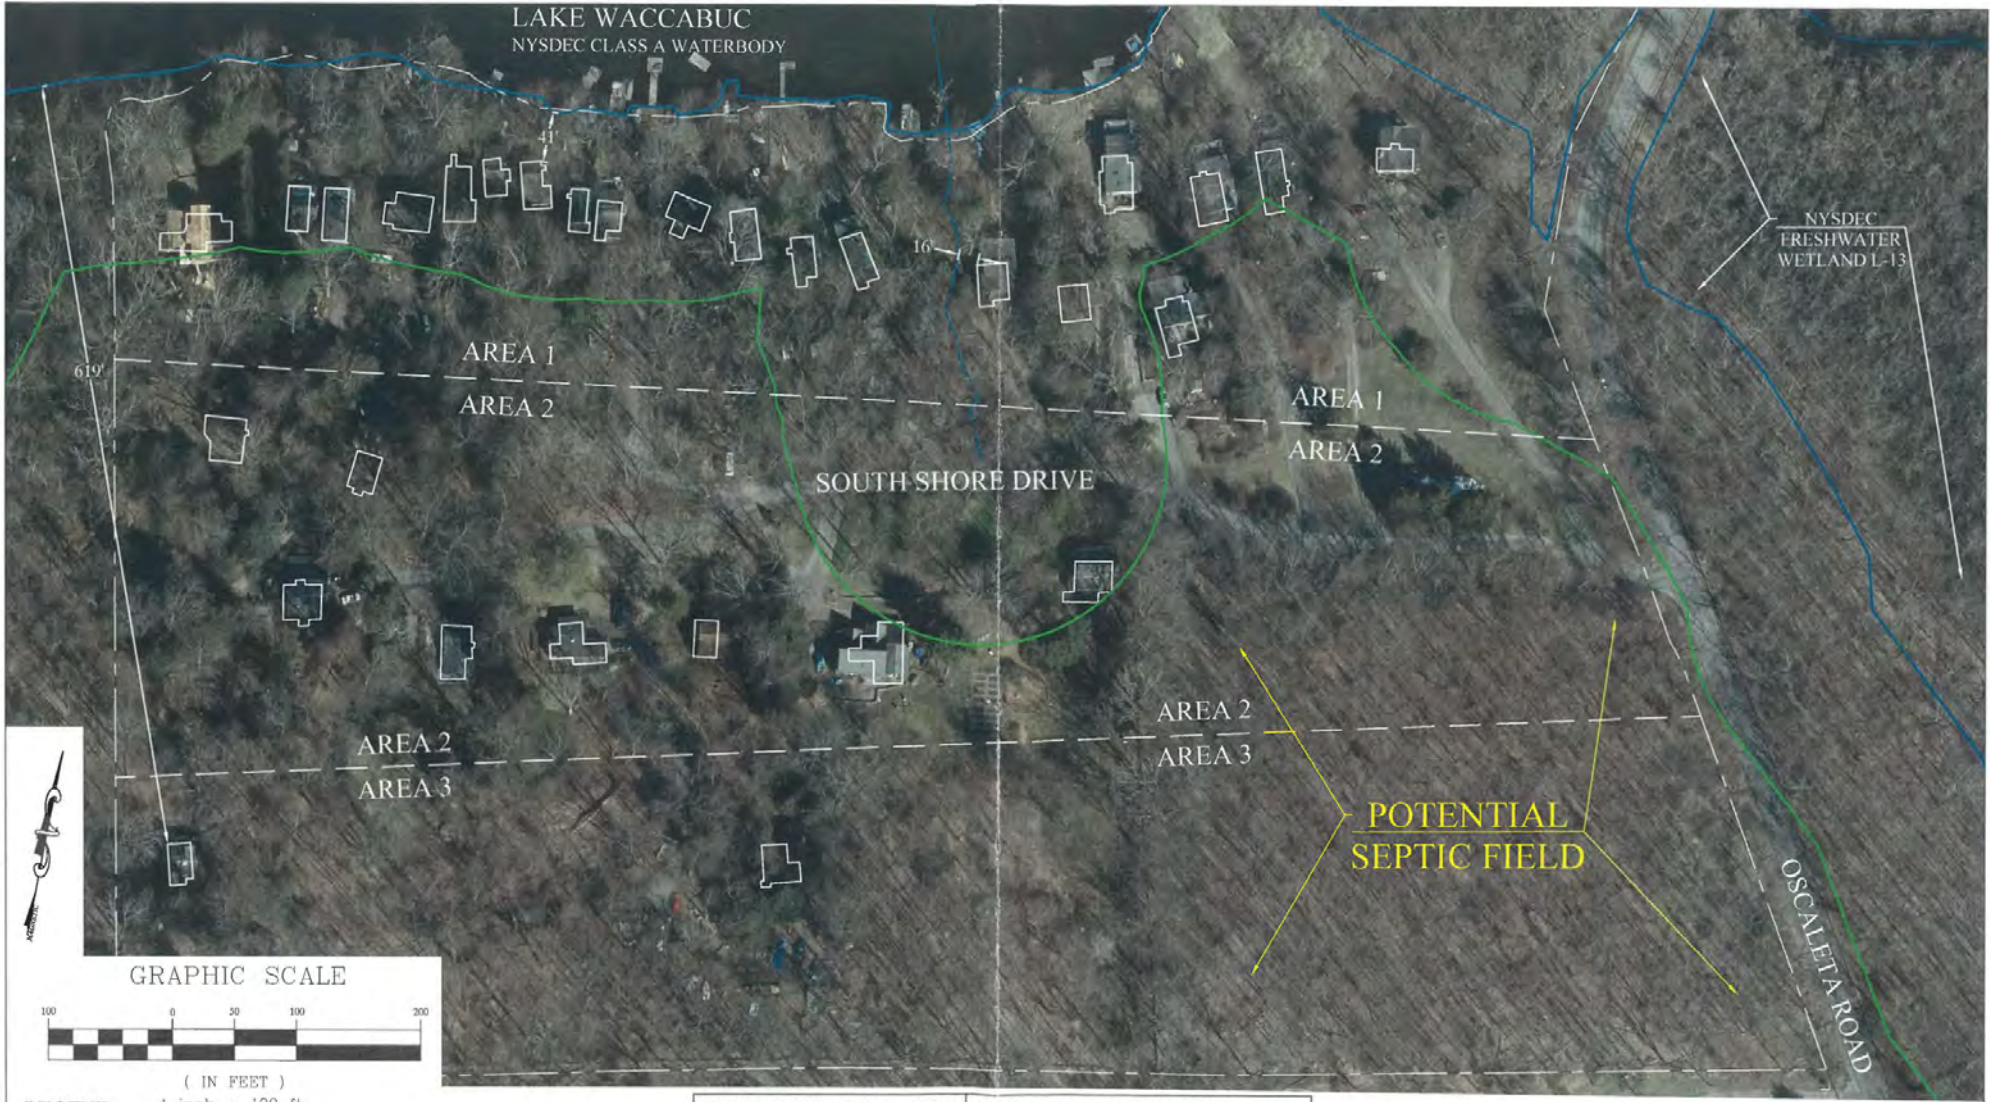
**SOUTH SHORE COMMUNITY**  
**ON-SITE WASTEWATER TREATMENT SYSTEM**  
 TOWN OF LEWISBORO, WESTCHESTER COUNTY, NY  
 KELLARD SESSIONS CONSULTING, P.C.
