# The Three Lakes Council

*2019 Aquatic Macrophyte Surveys at Three Lakes*

SOLITUDE  
LAKE MANAGEMENT

# 2019 Aquatic Macrophyte Surveys at Three Lakes: Lake Waccabuc

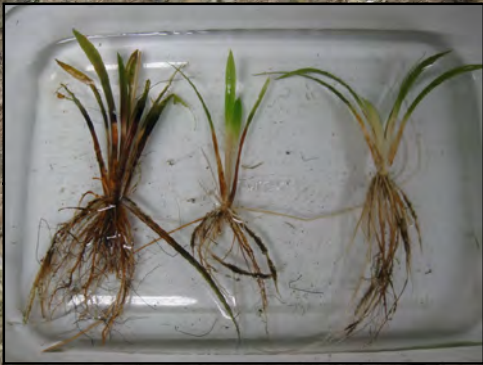
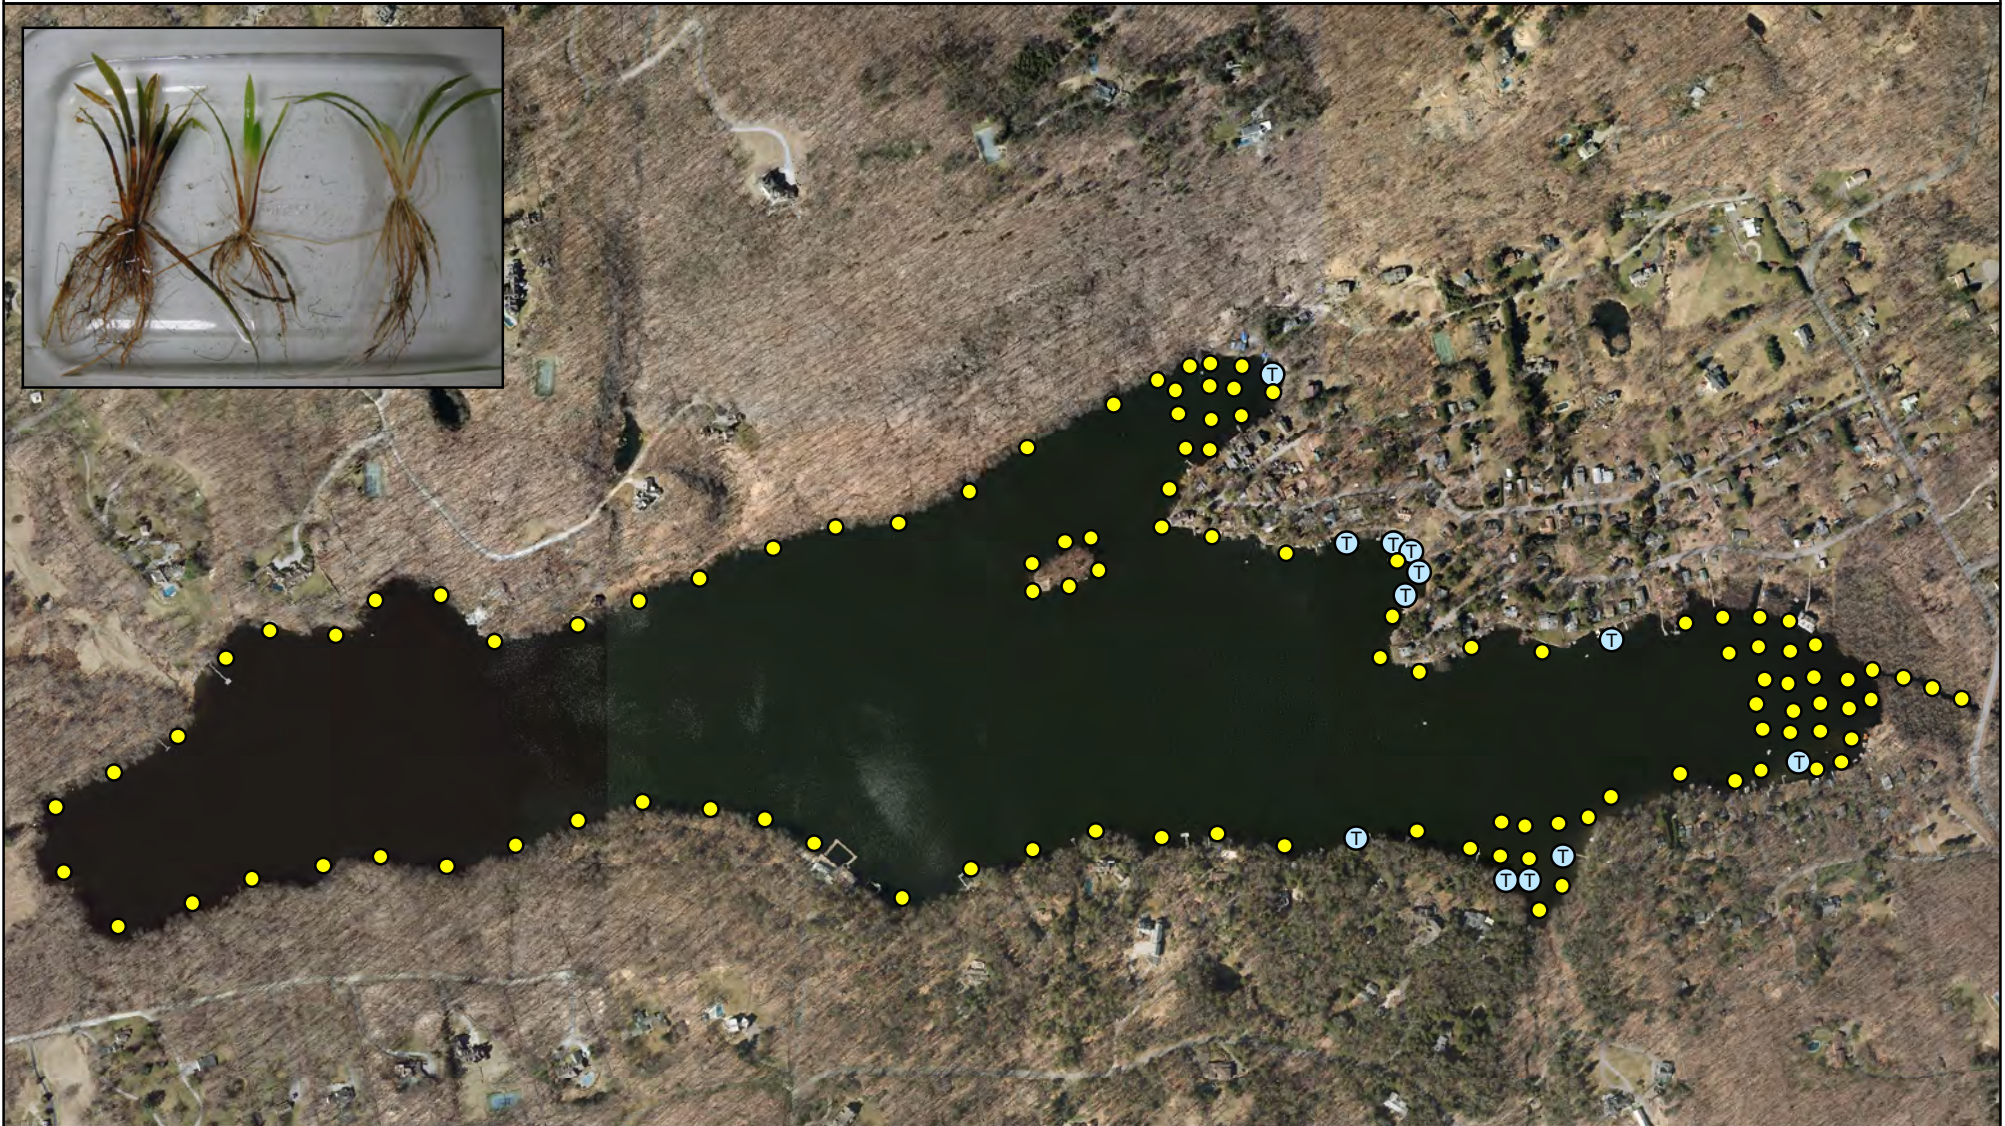
# ARROWHEAD ROSETTE (*Sagittaria* sp.) DISTRIBUTION

LAKE WACCABUC  
Aquatic Vegetation Survey  
July 30, 2019

Sample Sites: 120

Arrowhead rosettes were observed along the shorelines at 12 sites (or 10%). At low abundances, the majority of the sites (12 or 100%), were considered to be trace. Low abundances were observed scattered throughout the northern and southern shorelines, plus a presence in both the northern and southern cove.

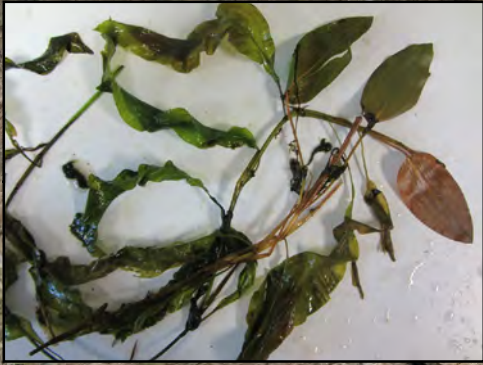
# BASSWEED (*Potamogeton amplifolius*) DISTRIBUTION

LAKE WACCABUC  
Aquatic Vegetation Survey  
July 30, 2019

Bassweed was observed throughout Lake Waccabuc at 45 sites (38%), but at fairly low abundances. Most of the sites made up of trace abundances (23 sites, or 38%). Sparse amounts were accounted for at eight sites (18%). Nine sites (20%) were observed at medium abundance, while five sites (11%) at dense abundances of bassweed were also recorded. Bassweed was scattered throughout the shorelines, decreasing in density towards the western end of the lake. Heavier abundances were observed in at the mouth of the canal. Various abundances were distributed throughout the northern cove, and along the southern shoreline.

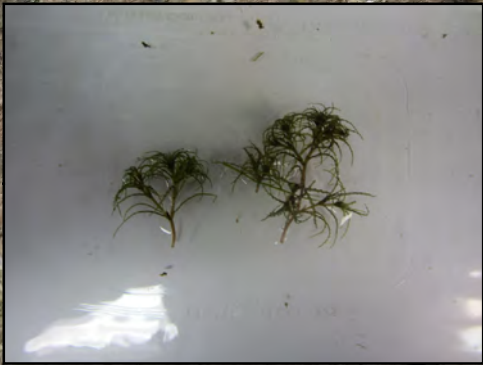
# BRITTLE NAIAD (*Najas minor*) DISTRIBUTION

LAKE WACCABUC  
Aquatic Vegetation Survey  
July 30, 2019

Brittle naiad, a low growing invasive species, was observed at six sites (3%) at trace abundances. This species was scattered along the northern, southern shorelines and near the canal.

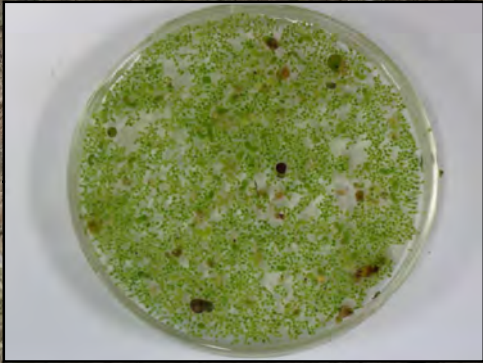
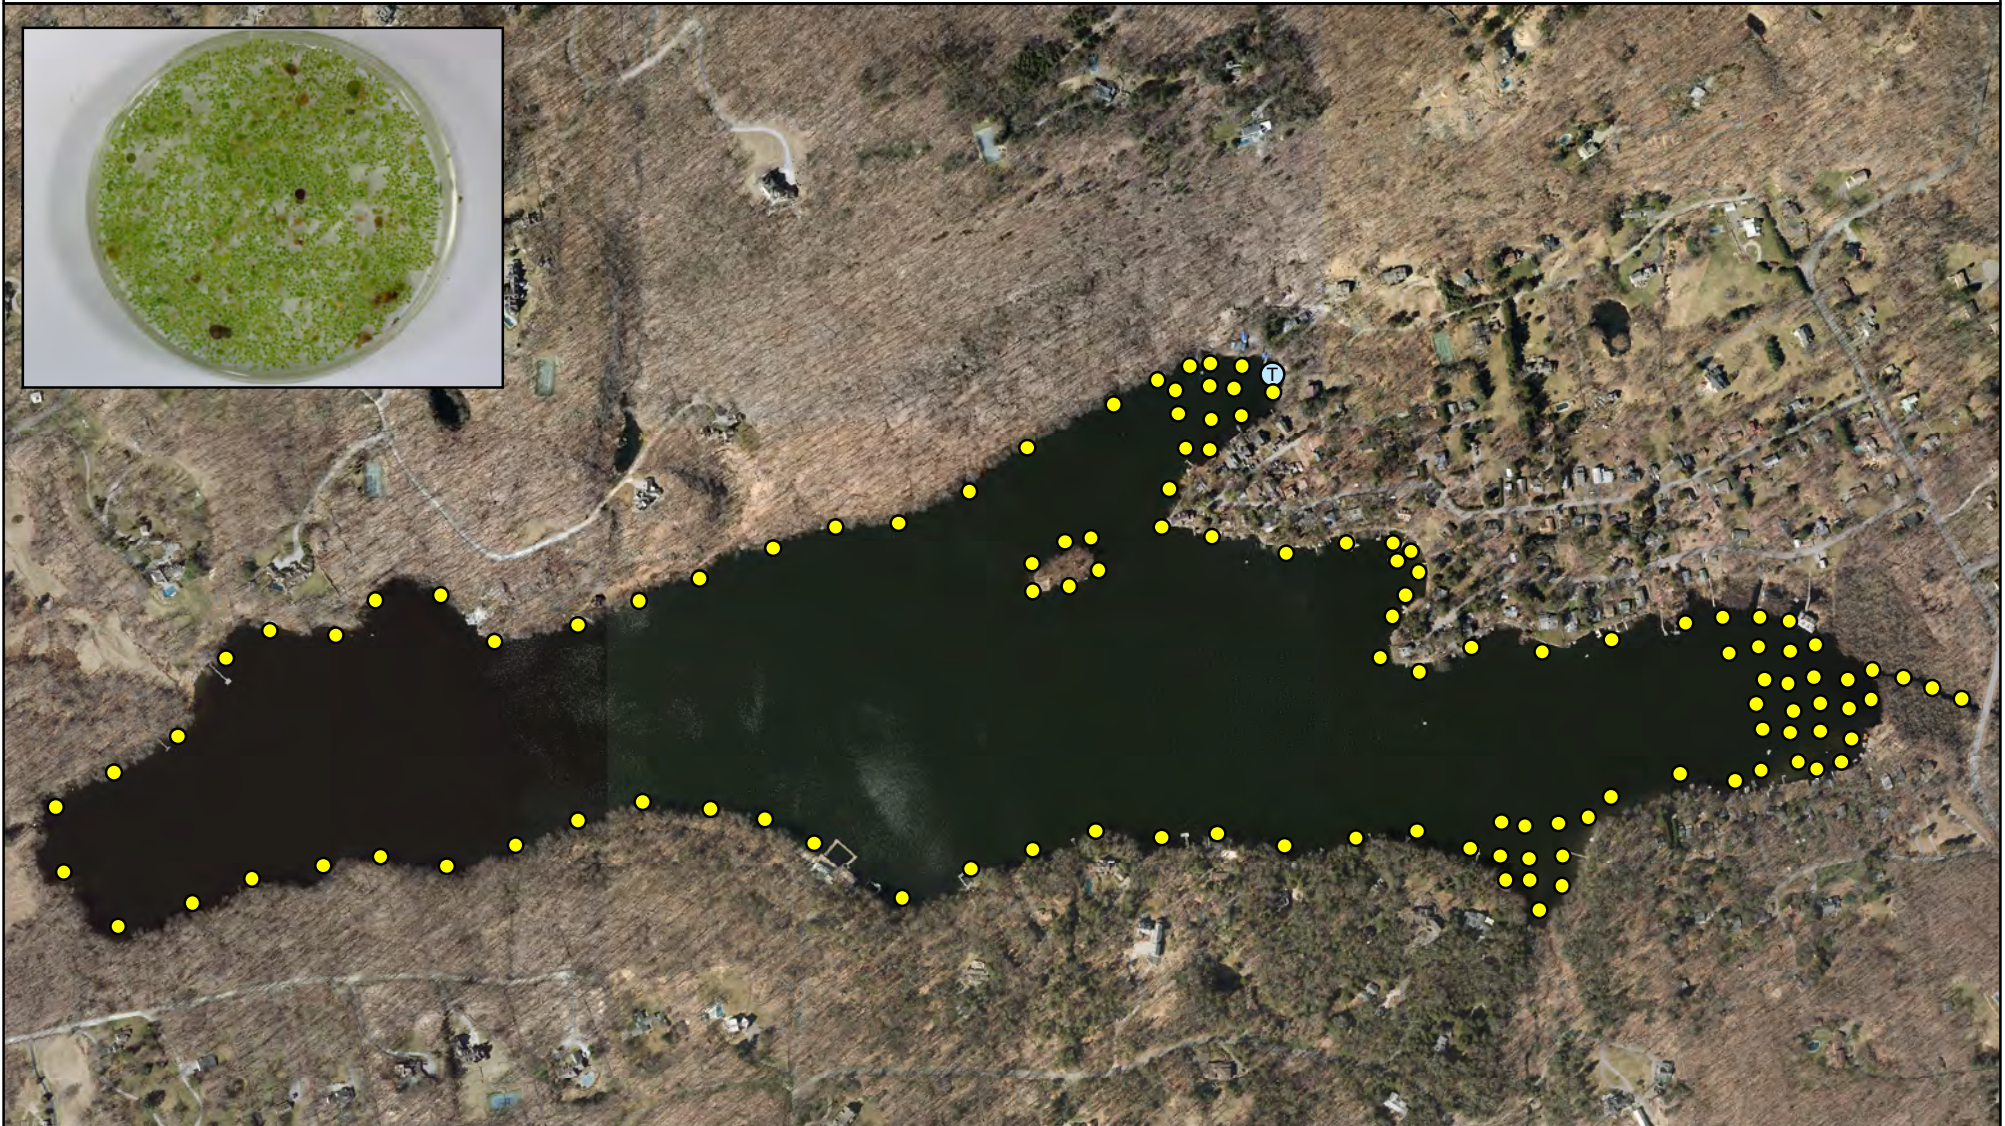
# COMMON WATERMEAL ( *Wolffia columbiana* ) DISTRIBUTION

LAKE WACCABUC  
Aquatic Vegetation Survey  
July 30, 2019

Common watermeal was observed at one site (1%) at low abundances. Watermeal was present in the northern cove shoreline. Watermeal often times can be found hidden amongst duckweed species and underneath other floating species.

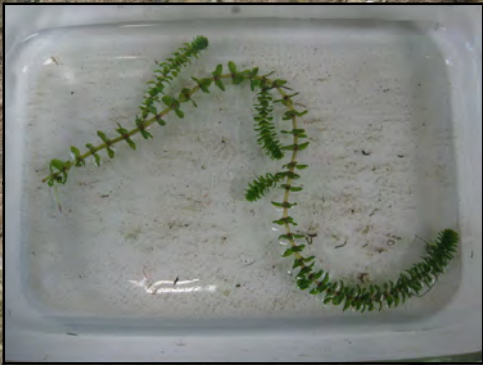
# COMMON WATERWEED ( *Elodea canadensis* ) DISTRIBUTION

LAKE WACCABUC  
 Aquatic Vegetation Survey  
 July 30, 2019

Common waterweed was observed at four sites (3%) at trace abundances. This native species was present in the northern cove and along the northern shoreline towards the mouth the canal.

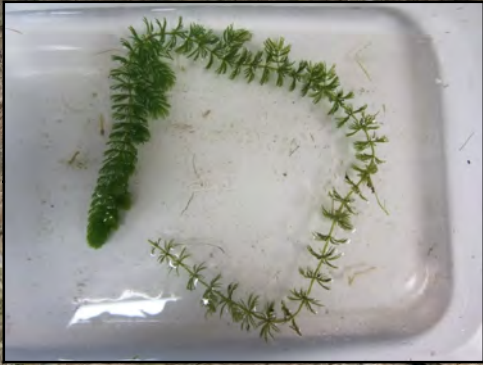
# COONTAIL (*Ceratophyllum demersum*) DISTRIBUTION

LAKE WACCABUC  
Aquatic Vegetation Survey  
July 30, 2019

Coontail, which was the second most common submersed macrophyte, was observed at 58 sites (or 48%) of the sites surveyed. Dense amounts of coontail was observed at two sites (3%) within the northern cove, while five sites were recorded at medium abundance (9%). Sparse abundances were observed at 12 sites (or 21%) and trace abundances were observed at 39 sites (67%). The majority of the coontail occurrences were concentrated at the mouth of the canal and in the canal itself. Other areas were scattered with trace and sparse amounts throughout the shorelines.

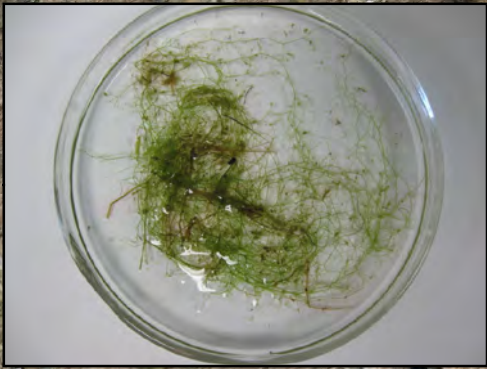
# CREEPING BLADDERWORT (*Utricularia gibba*) DISTRIBUTION

LAKE WACCABUC  
Aquatic Vegetation Survey  
July 30, 2019

Creeping bladderwort, a free-floating species often found at the surface, was observed at eight sites (7%). Seven sites (88%) were identified at trace abundances, while the remaining site was considered sparse (13%). Concentrations of this population were observed in the canal, along with one sparse site located along the northern main shoreline.

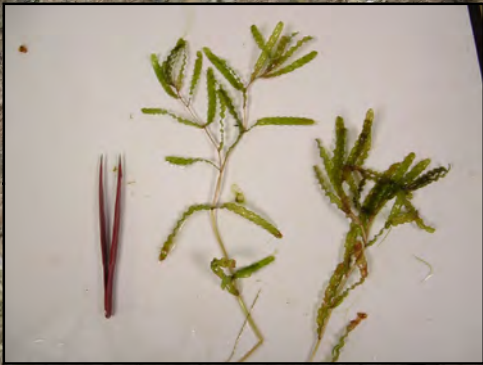
# CURLY-LEAF PONDWEED (*Potamogeton crispus*) DISTRIBUTION

LAKE WACCABUC  
Aquatic Vegetation Survey  
July 30, 2019

Curly-leaf pondweed was observed at two sites (2%) at trace abundances. This seasonally influenced invasive species was observed along the northern shoreline.

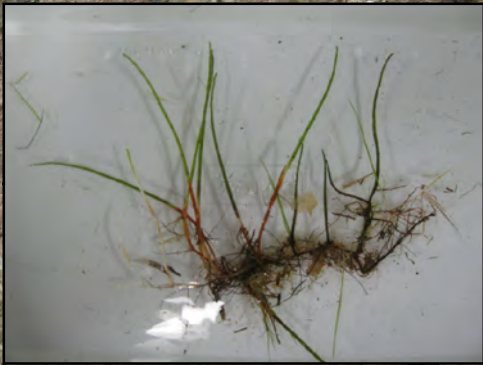
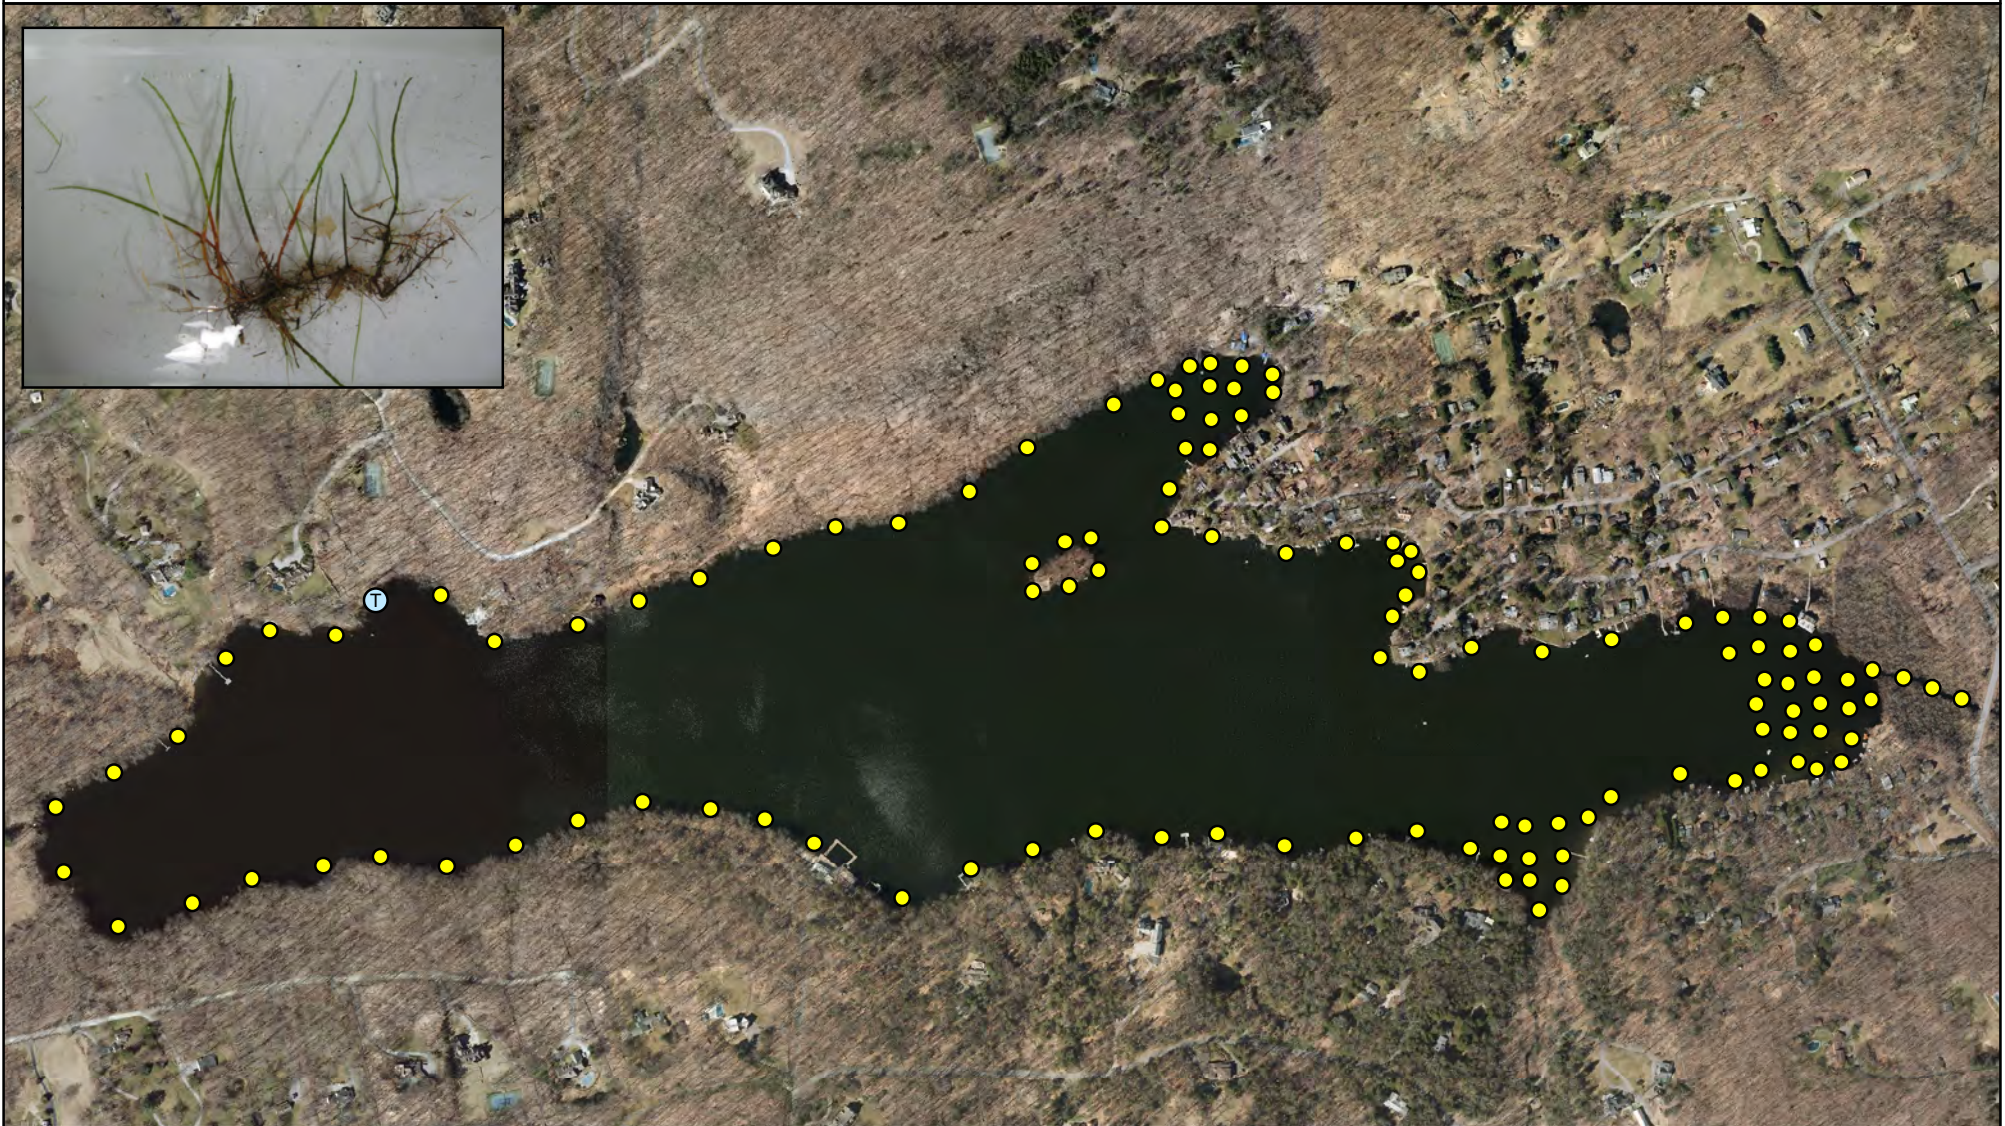
# DWARF WATERMILFOIL (*Myriophyllum tenellum*) DISTRIBUTION

LAKE WACCABUC  
Aquatic Vegetation Survey  
July 30, 2019

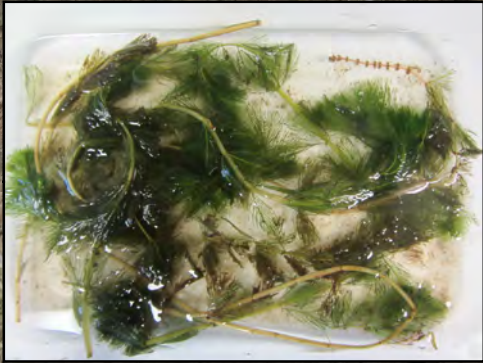
# EURASIAN WATERMILFOIL (*Myriophyllum spicatum*) DISTRIBUTION

LAKE WACCABUC  
Aquatic Vegetation Survey  
July 30, 2019

- Eurasian watermilfoil continues to be the most dominant macrophyte within Lake Waccabuc.
- **No Brazilian elodea and water chestnut were found.** For the ninth consecutive year, no Brazilian elodea was collected or observed and for the fifth year no water chestnut was collected or observed.

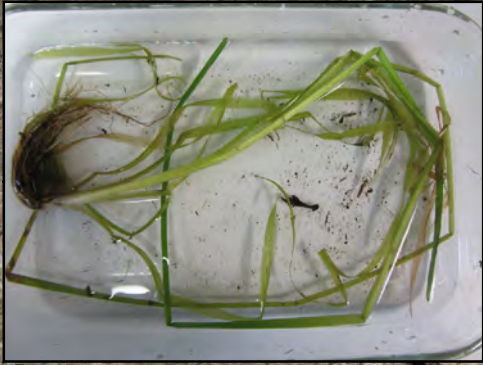
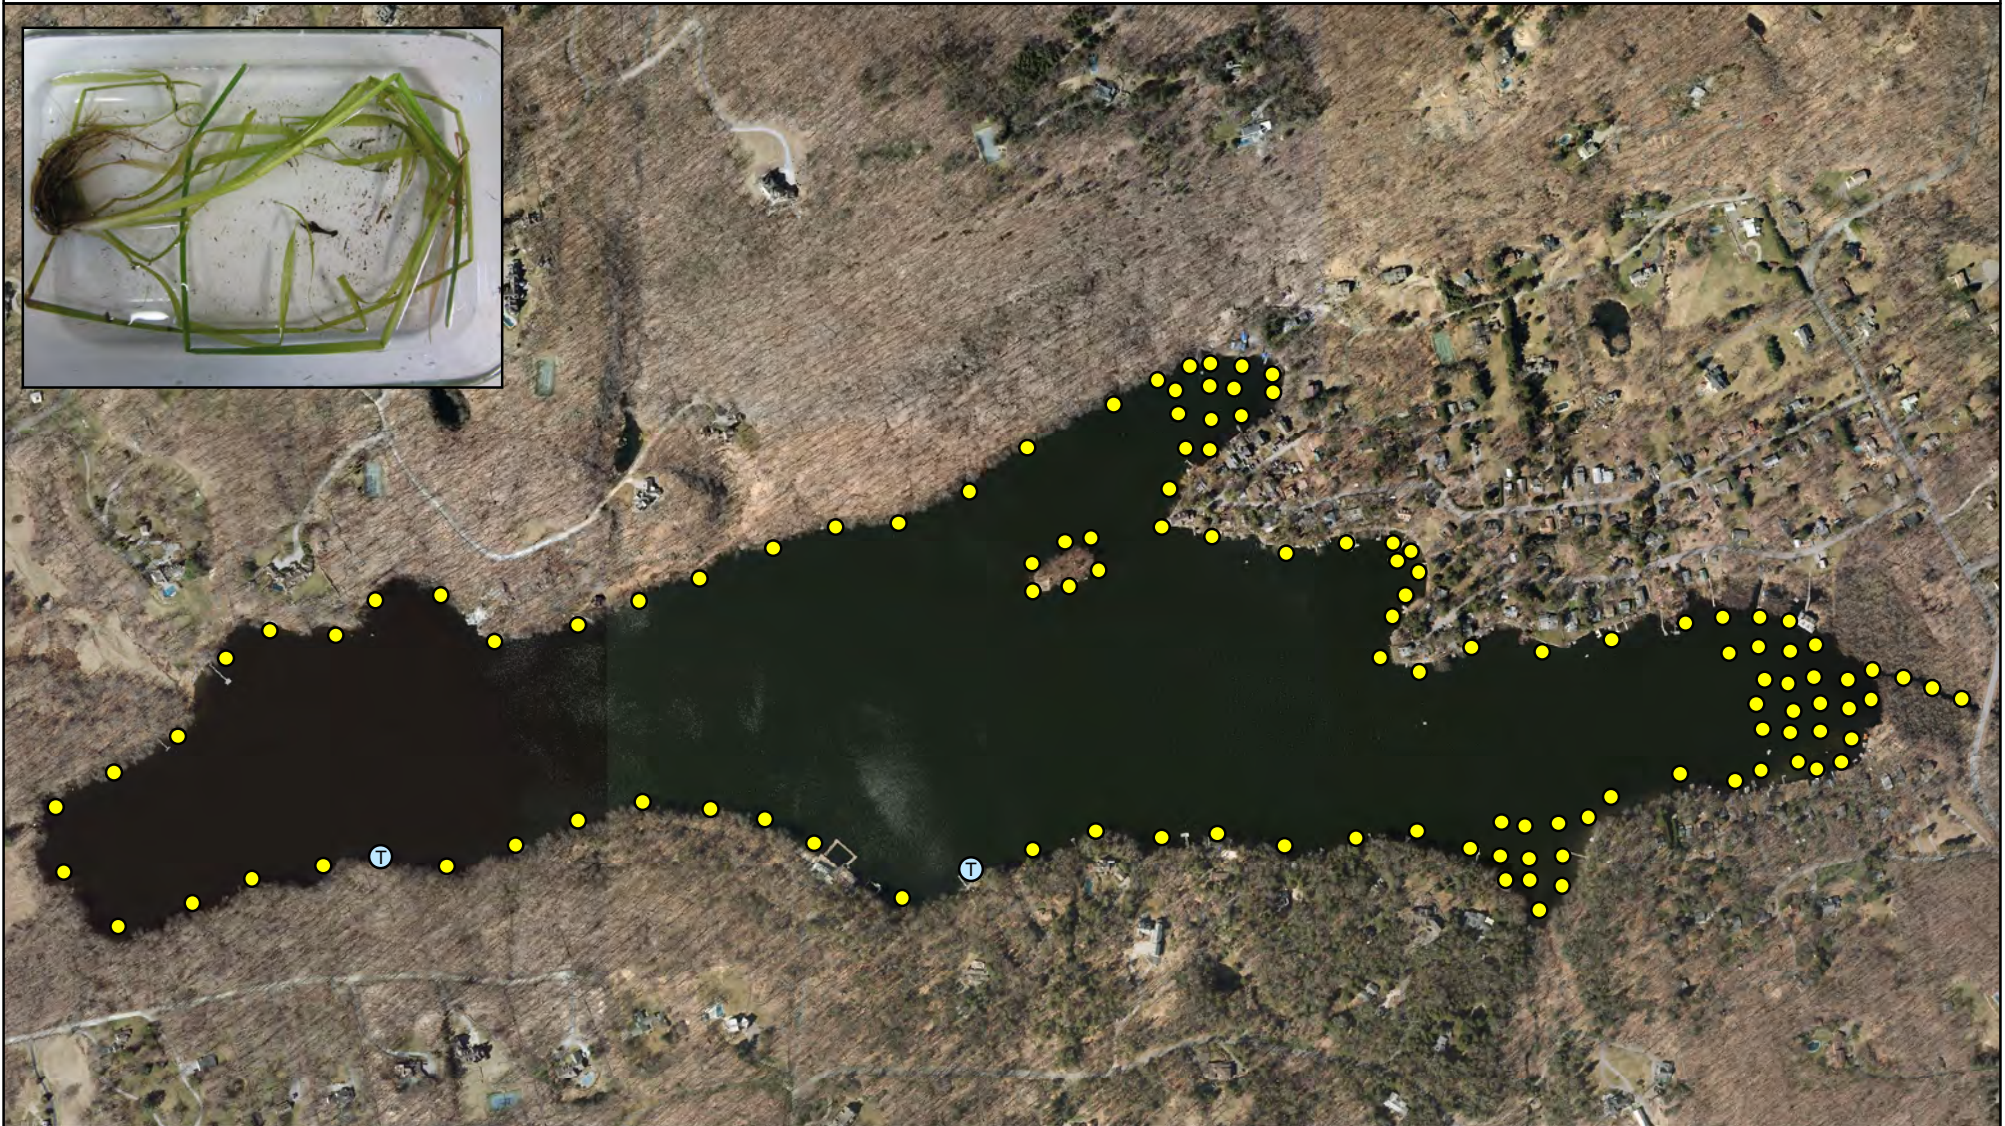
# FLOATING BUR-REED (*Sparganium fluctuans*) DISTRIBUTION

LAKE WACCABUC  
Aquatic Vegetation Survey  
July 30, 2019

Based on the characteristics we could identify; biologist believe Floating Bur-reed was present at two sites (2%) along the southern shoreline at trace abundances. However, the samples that were examined were significantly damaged. It's possible that uprooted fragments of bur-reed may have gotten uprooted, via fish activity or recreational boaters, from the canal area and was transported to the southern shoreline area. Typically, bur-reed has historically only been found in canal area, where it prefers flowing waters.

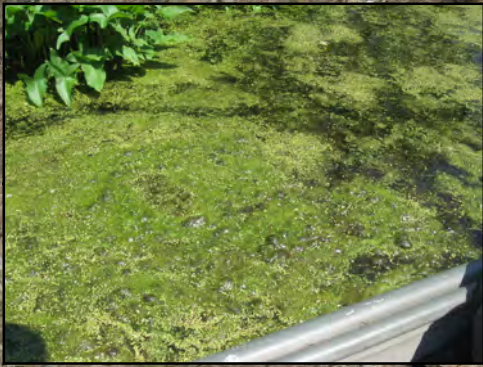
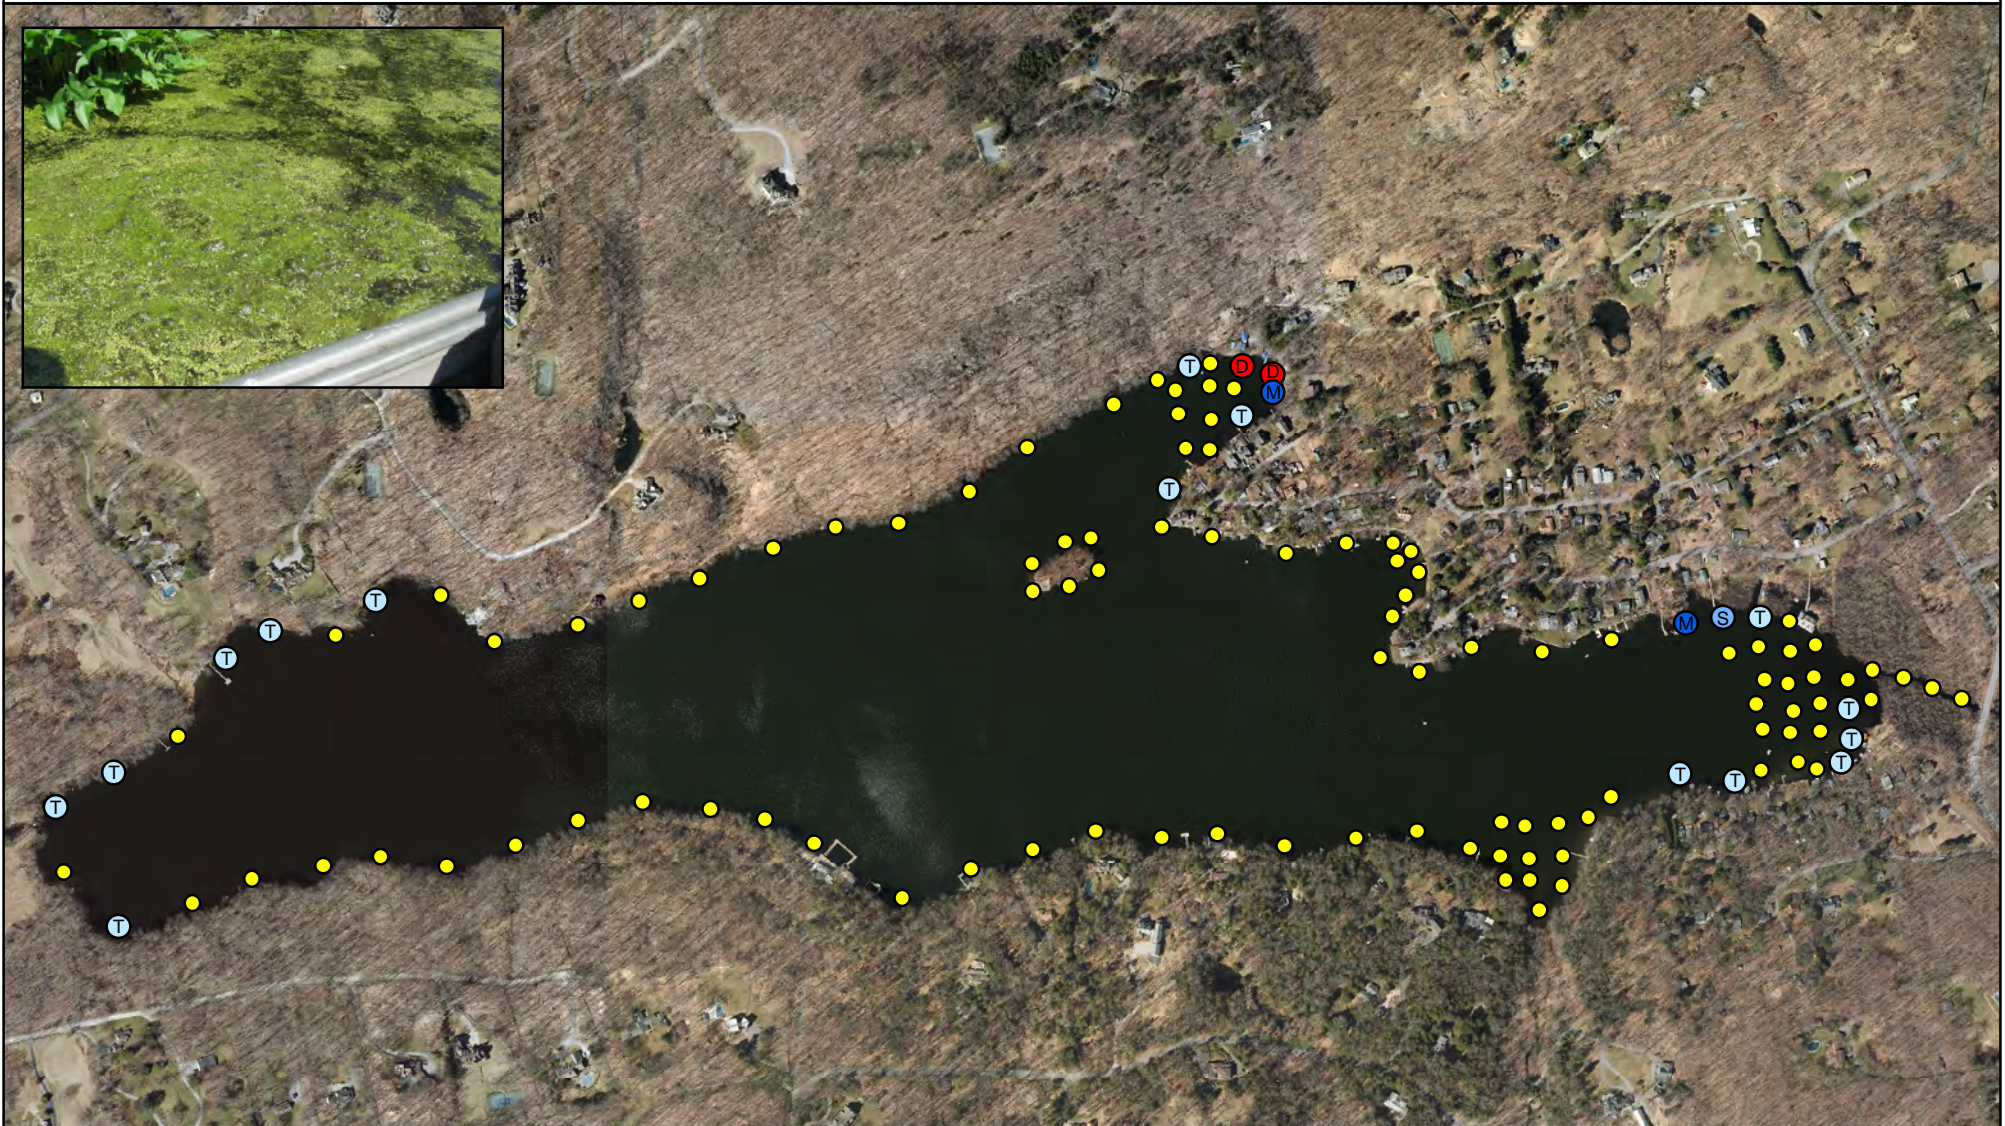
# FLOATING FILAMENTOUS ALGAE DISTRIBUTION

LAKE WACCABUC  
Aquatic Vegetation Survey  
July 30, 2019

A total of 20 sites (or 17%) of floating filamentous algae were observed. Two dense sites (10%) was accounted for and two medium sites (10%) was recorded. One site (5%) was considered sparse and

15 sites (75%) were recorded at trace abundance. Filamentous algae were observed along the northeastern shorelines and southeastern shorelines. Heavier populations were observed in the north cove and lighter concentrations were identified along the shorelines near the eastern end of the basin.

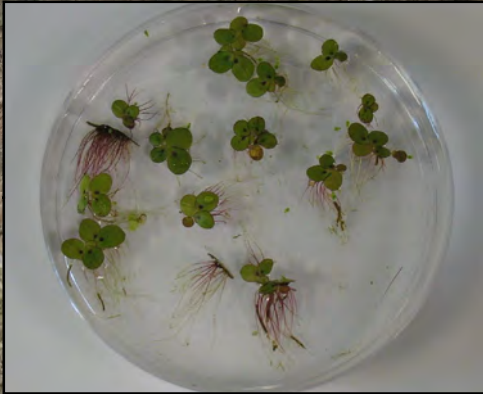
# GREAT DUCKWEED (*Spirodela polyrhiza*) DISTRIBUTION

LAKE WACCABUC  
Aquatic Vegetation Survey  
July 30, 2019

Great duckweed was observed at seven (6%) of the sites surveyed. Trace abundances were observed at five sites (71%), while two other sites (29%) were observed at sparse abundance. Great duckweed was observed in the canal and just outside of the canal area. Trace amounts were recorded in the north cove.

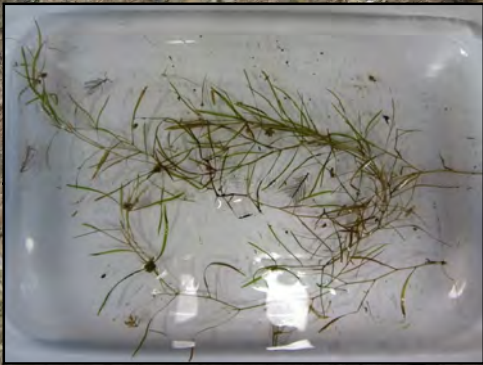
# LEAFY PONDWEED (*Potamogeton foliosus*) DISTRIBUTION

LAKE WACCABUC  
Aquatic Vegetation Survey  
July 30, 2019

Leafy pondweed was observed at 16 (or 13%) of the sites surveyed. All sites were observed at trace abundances scattered along the northern and southern shorelines.

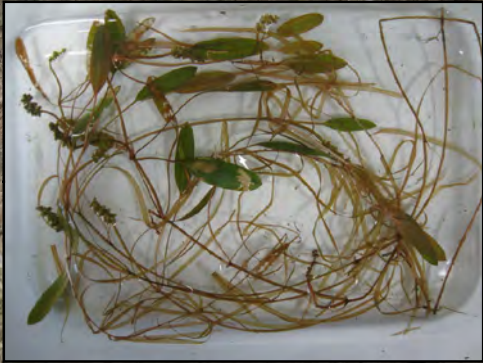
# RIBBON-LEAF PONDWEED (*Potamogeton epiphydrus*) DISTRIBUTION

LAKE WACCABUC  
Aquatic Vegetation Survey  
July 30, 2019

Ribbon-leaf pondweed, a native species, was observed at 11 sites (9%) at Lake Waccabuc. Trace amounts were observed at seven sites (64%). Two sites (18%) were observed at medium abundance and two sites (or 18%) were found at dense abundances. Robust communities of ribbon-leaf pondweed were observed in the canal. Ribbon-leaf pondweed were also observed at the eastern and western end of the lake.

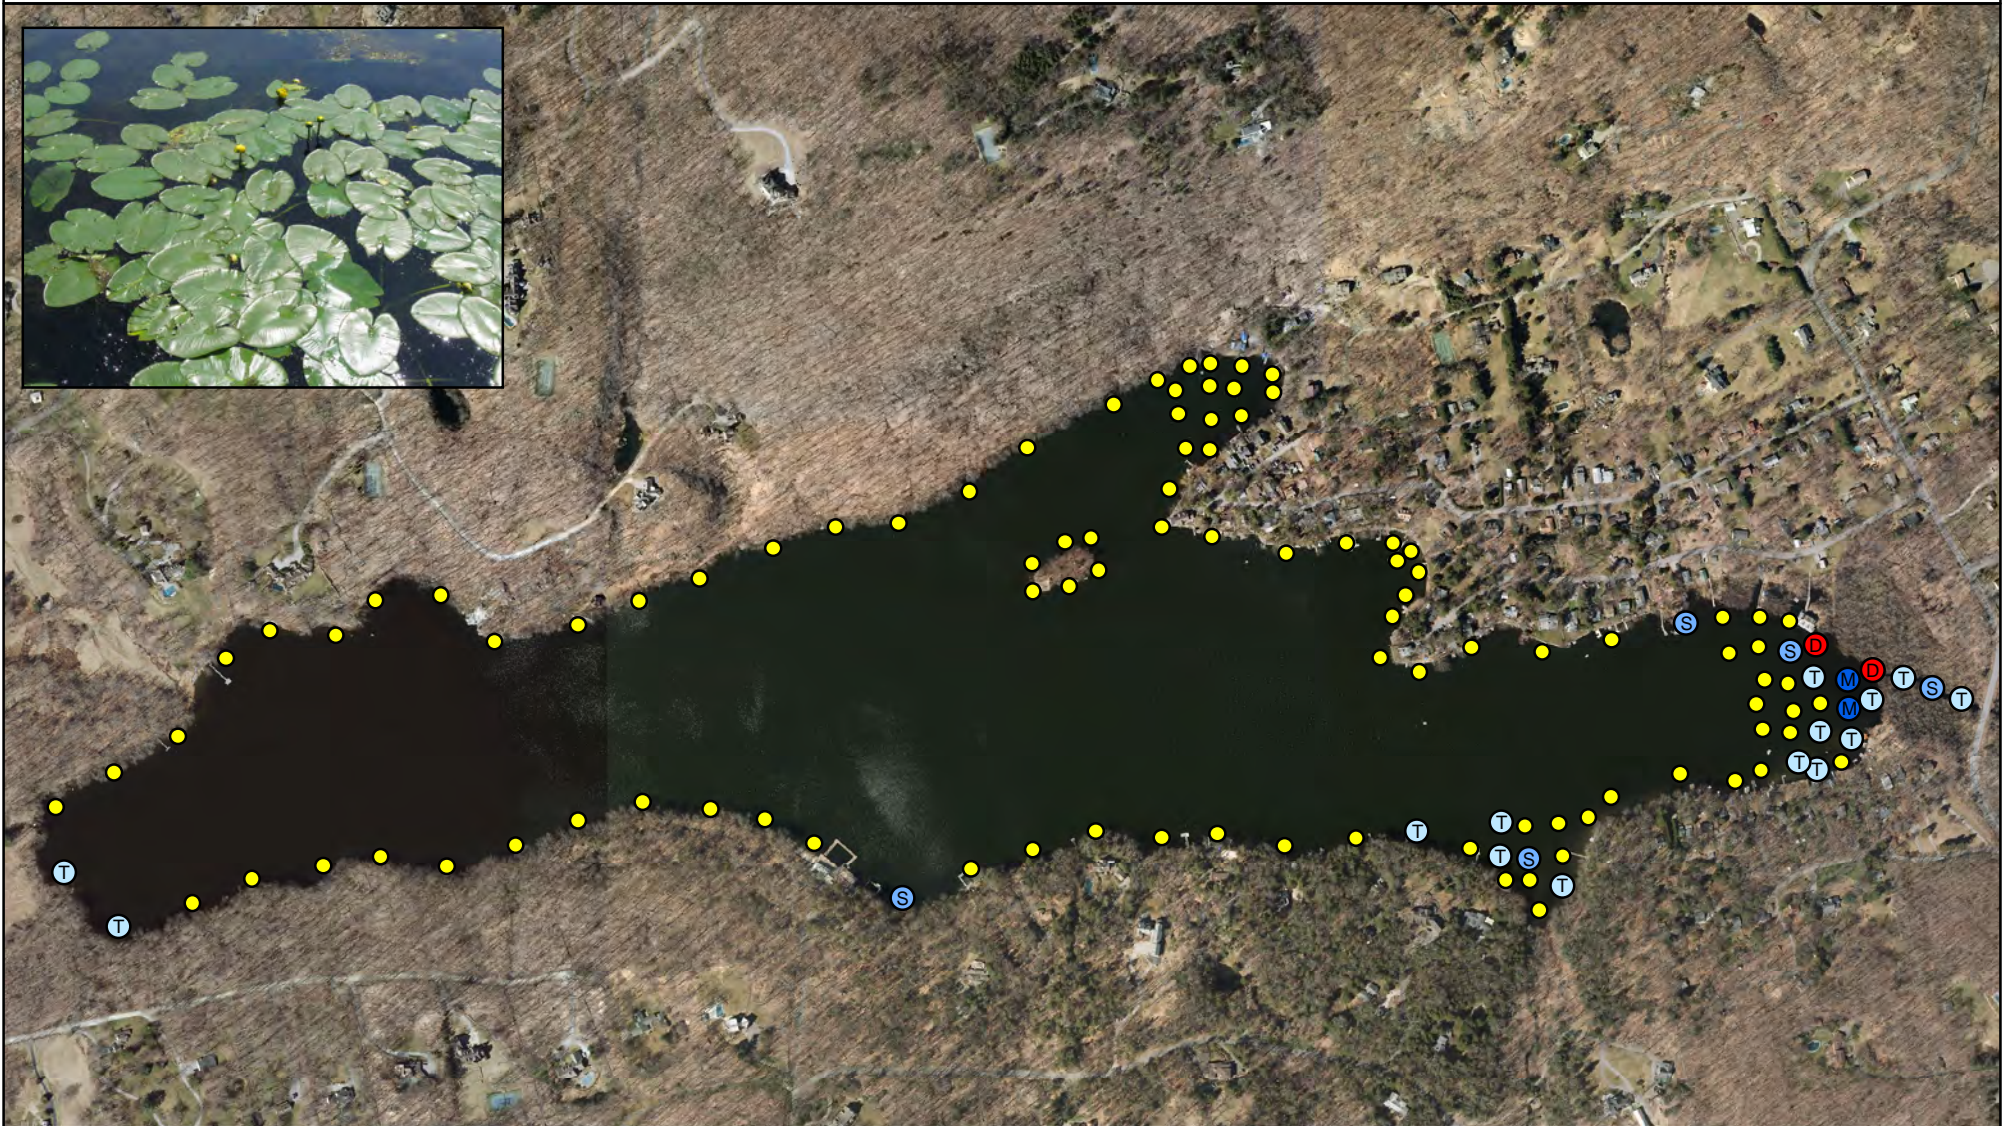
# SPATTERDOCK (*Nuphar variegata*) DISTRIBUTION

LAKE WACCABUC  
Aquatic Vegetation Survey  
July 30, 2019

Spatterdock, also known as yellow lily, was observed at 23 sites (or 19%). Nuisance levels were observed at dense abundances (two or 12%) and medium abundances at two (or 12%) sites. Sparse amounts were recorded at five (22%) sites and trace abundances occurred at 14 (or 61%) sites. Spatterdock was present throughout the eastern end of the lake mixed in with other lily species. Densities decreased along the shorelines approaching towards the western end of the lake.

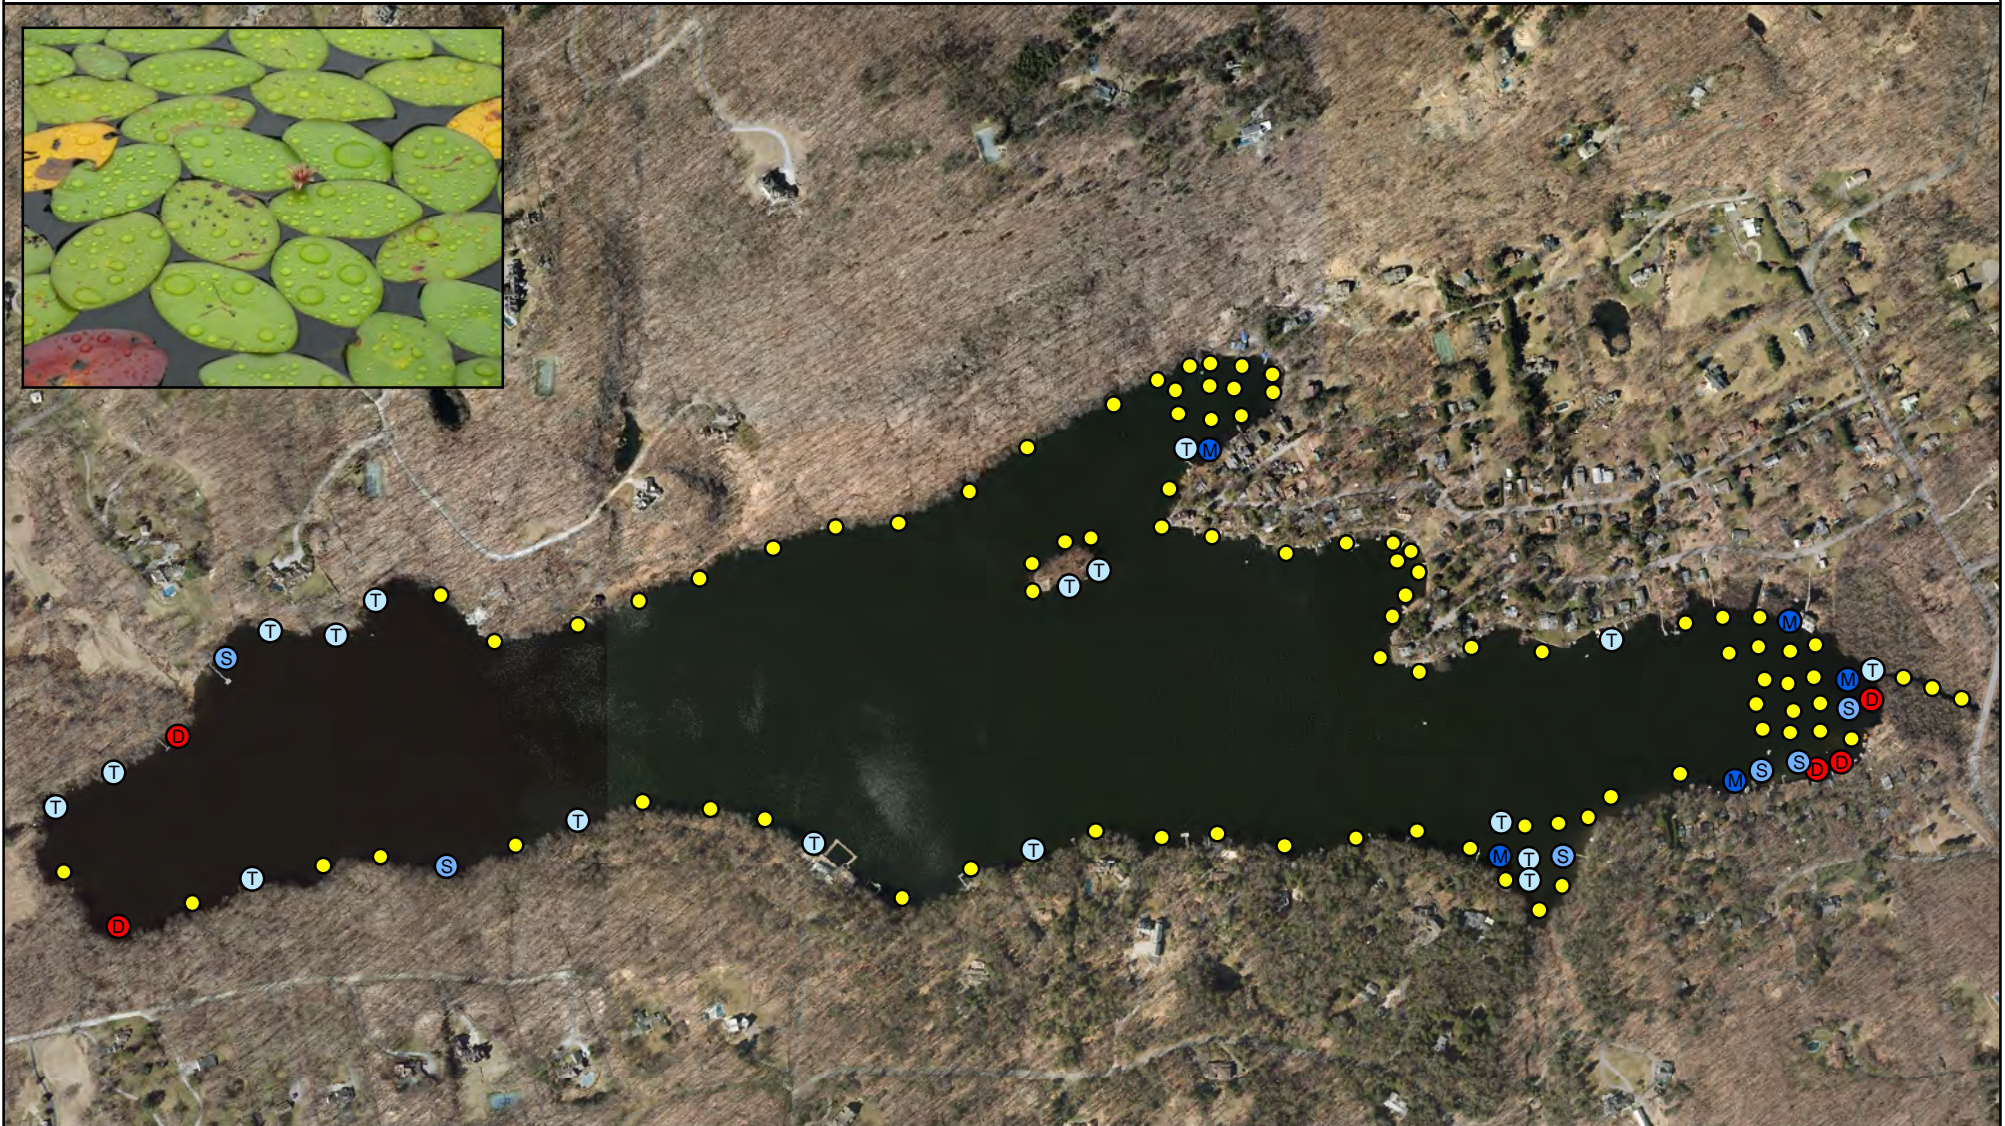
# WATERSHIELD (*Brasenia schreberi*) DISTRIBUTION

LAKE WACCABUC  
Aquatic Vegetation Survey  
July 30, 2019

Watershield, often mixed in with other lily species, was observed at 33 sites (32%) at various abundances. Dense abundances were observed at five sites (15%) and medium abundances were found at five sites (15%) of the sites surveyed. Sparse amounts were identified at six sites (18%) and trace amounts were observed at 17 sites (52%) each. Heavier populations occurred at the eastern end of the lake and lighter abundances were present at the opposite end of the lake.

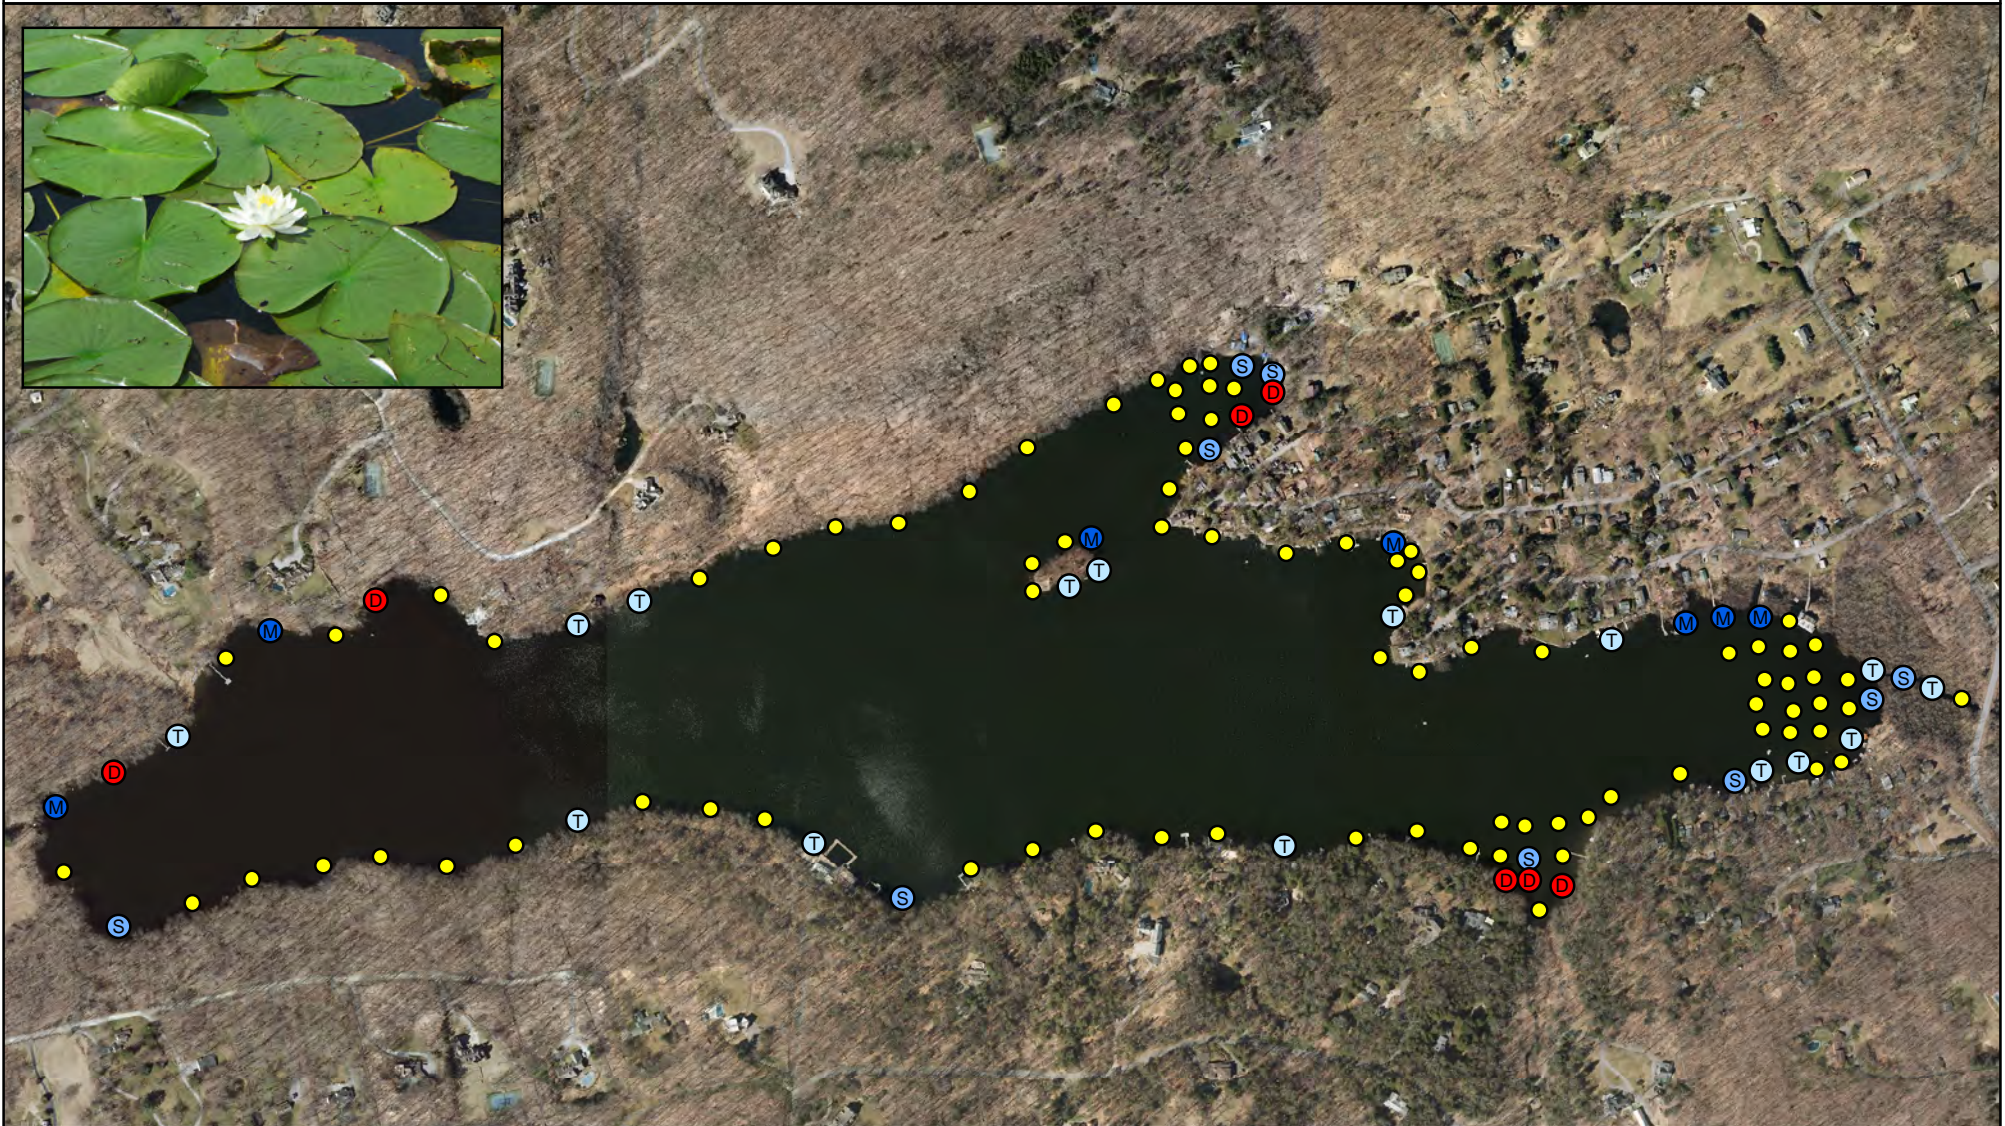
# WHITE WATER LILY (*Nymphaea odorata*) DISTRIBUTION

LAKE WACCABUC  
Aquatic Vegetation Survey  
July 30, 2019

White water lilies were observed at 38 sites (or 32%) of the sites surveyed. A number of sites were considered to have nuisance level abundance. Dense abundances were observed at seven sites (18%) and medium abundances were present at seven sites (18%). Sparse abundances were recorded at nine sites (24%) and trace abundances were observed at 15 sites (39%). Densities were scattered throughout towards the western, southern cove and northern areas of the lake.
